# Investigation Report into November 2019 Derwent Floods in Derby City

Derby City Council

Project number: 60675186

15th September 2022

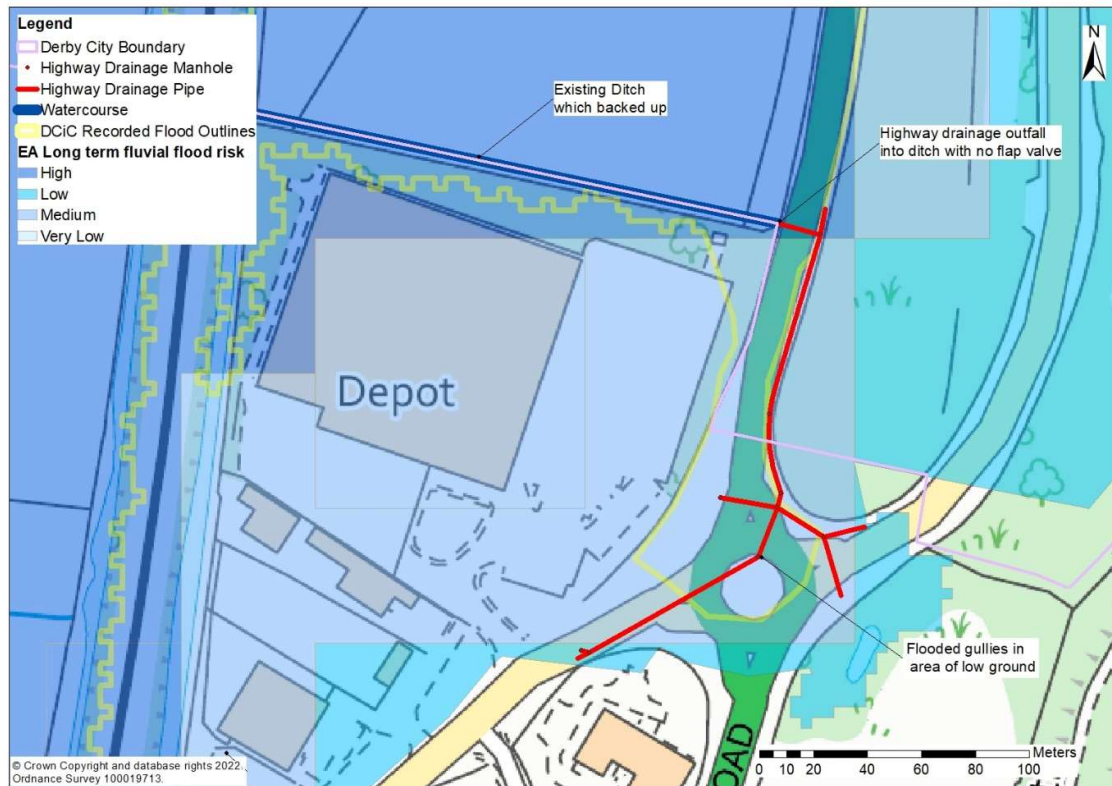
**Figure 5-10: November 2019 Recorded flood outlines at A61 North of Pektron Roundabout**

During the flood event Pektron Island Roundabout on the A61 experienced significant flooding with water depths of approximately 500mm, resulting in the need to close the roundabout for a period of time. Pektron Island was underwater by 21:45 on 8<sup>th</sup> of November. The flooding was reported as being caused by fluvial water flooding from the gullies of the highway drainage network.

Figure 5-10 shows the drainage system within the area including the highway drainage network and the outfall of this network into an existing ditch that ultimately discharges into the River Derwent. The ditch is privately owned, through third-party riparian ownership and is split between DCiC bounds and Derbyshire County Council bounds. Based on observations on site, the ditch has very little fall along its length and is poorly maintained. Due to the high water levels in the river during the flood event and the lack of fall along the length of the ditch, fluvial flows from the river are believed to have entered the ditch causing the water levels in the ditch to exceed the height of the highway drainage outfall. The outfall does not have a non-return valve on it, therefore as water levels in the ditch rose above the outfall, fluvial water entered the highway drainage system, eventually emerging through the gullies around the roundabout which are at a lower level than the ditch, causing flooding of the highway even without significant rainfall occurring in Derby on the day of the flooding. Figure 5-10 also shows that the area that flooded is an area known to be at risk of surface water flooding with areas of low, medium and high risk.

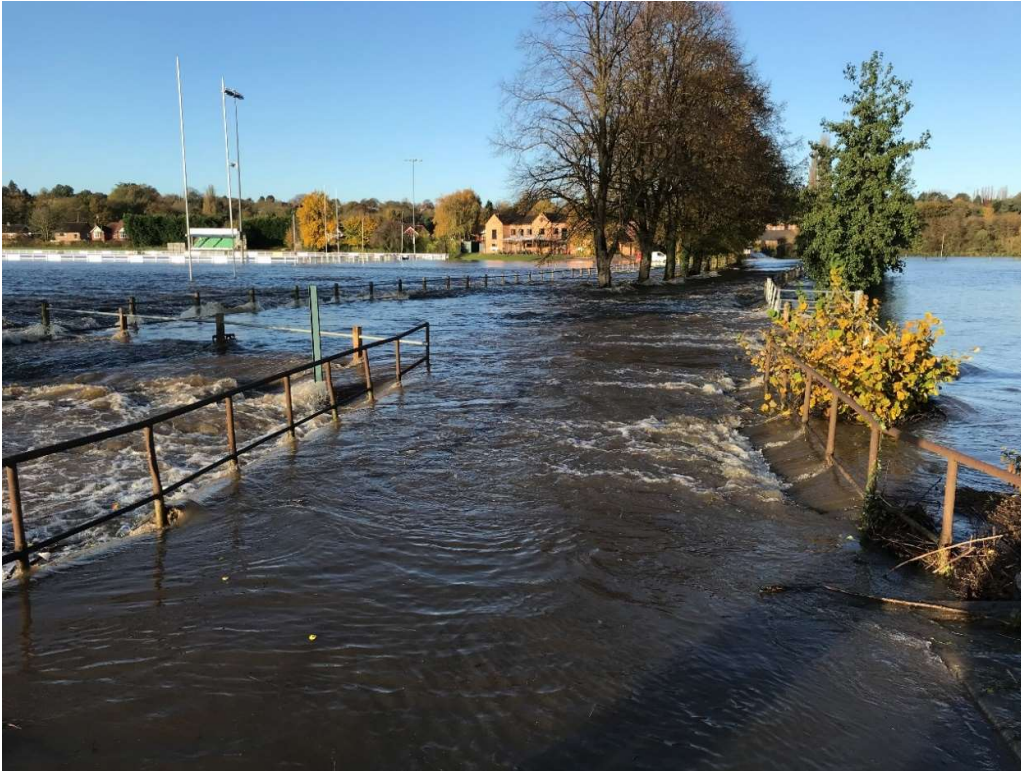
Figure 5-13: Photo taken looking towards Derby Rugby Football Grounds (8:53 8<sup>th</sup> November 2019)

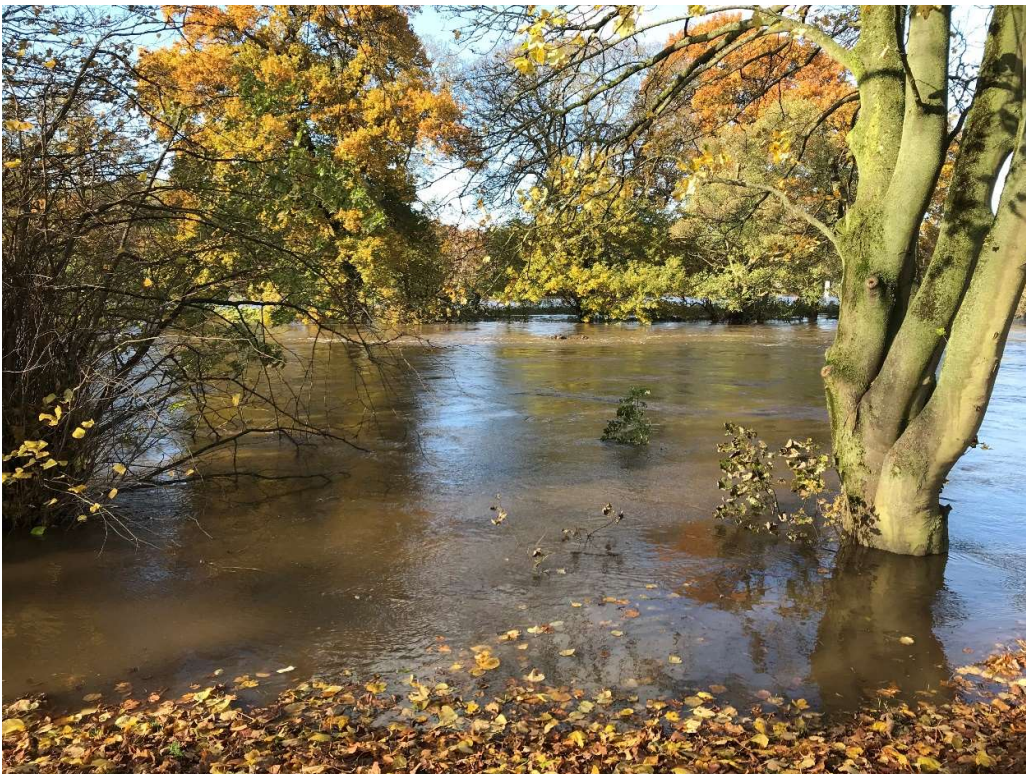
Figure 5-12: Photo showing flooding in Darley Fields (12:20 8<sup>th</sup> November 2019)

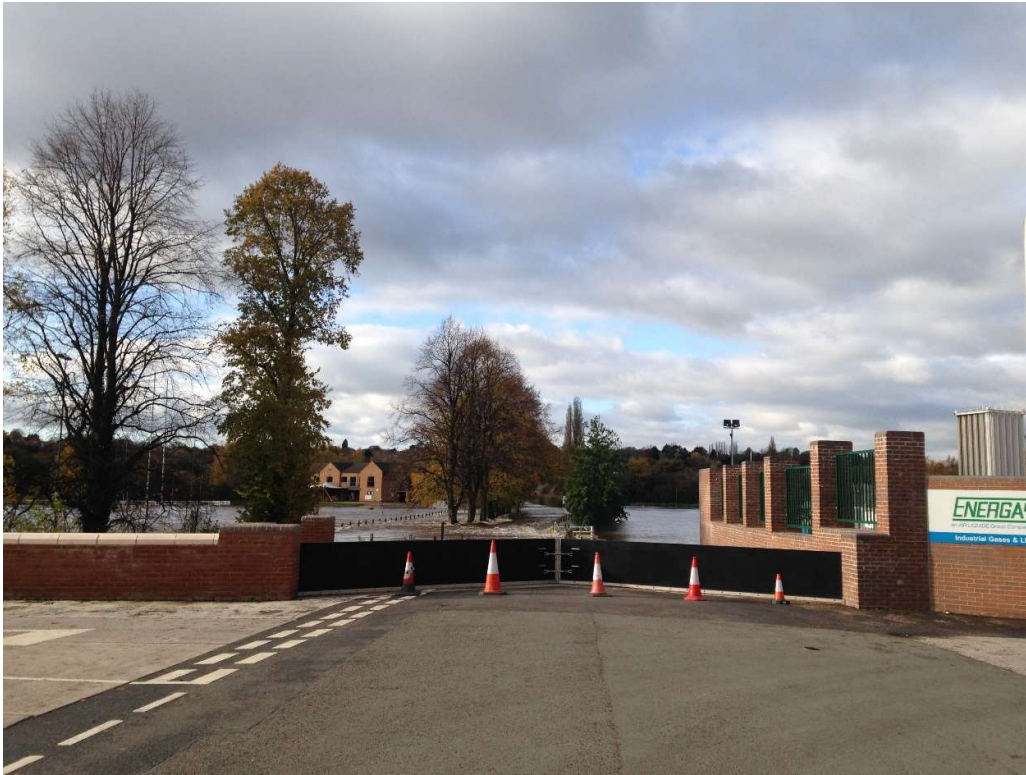
Prior to this flood event, as part of the OCOR scheme<sup>12</sup> (Derby's flood alleviation project, led by DCiC in partnership with the EA), the road at Haslams Lane had been regraded and a flood gate installed (Figure 5-14). During the event the flood gate on Haslams Lane was closed at approximately 2 pm on 8<sup>th</sup> of November and reopened the following morning.

**Figure 5-14: Photo showing flood gate on Haslams Lane closed during the flood event (13:12 8<sup>th</sup> November 2019)**

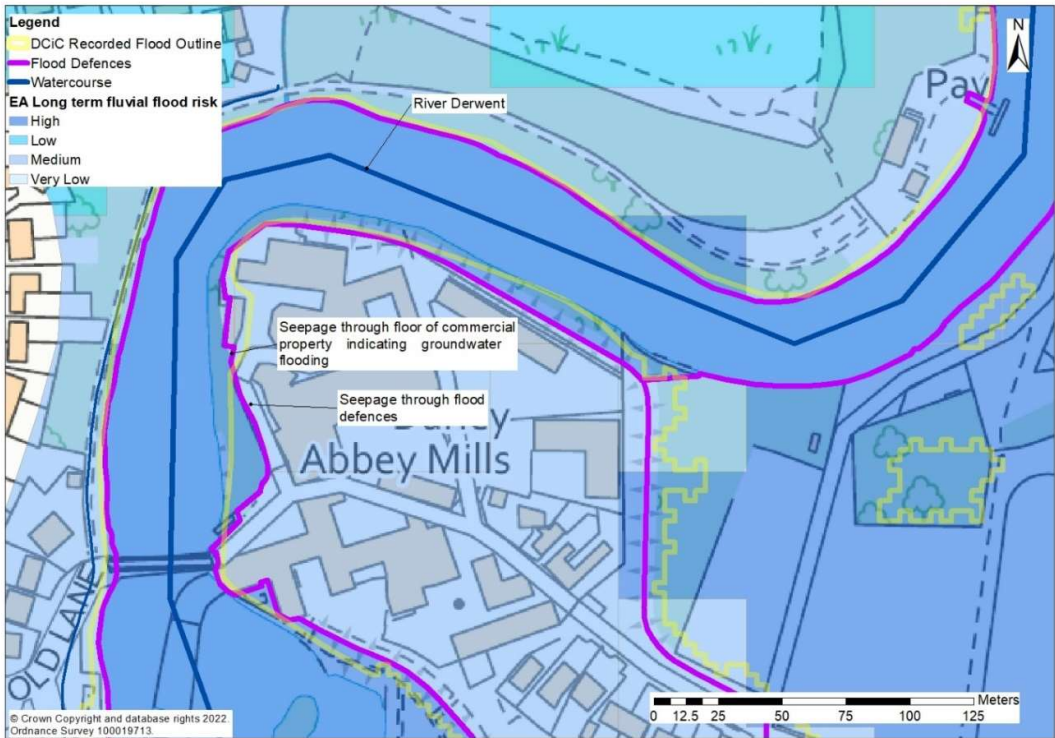
Figure 5-16: November 2019 Recorded flood outlines at Darley Abbey Mills

Figure 5-16 shows that Darley Abbey Mills is surrounded by flood defences, which are a combination of flood walls and embankments. It can be seen from the DCiC recorded flood outline shown on the figure that these defences were not overtopped during the flood event, which is corroborated by observations from commercial property staff present in the Darley Abbey Mills during the event. However, seepage was reported through the flood defences, which is thought to have resulted in internal flooding in at least one commercial property up to a depth of approximately 150 mm (see Figure 5-15), and disruption to commercial business due to lack of access. In addition to the fluvial water seeping through the existing defences, the employees of the commercial property that were present during the flooding have reported that water was seeping through from the floors which indicates groundwater flooding.

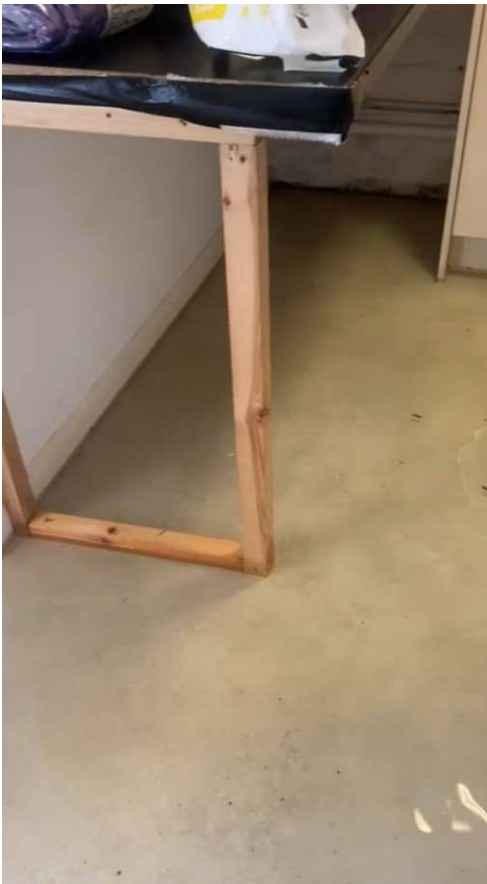
Figure 5-15: Internal flooding in commercial property in Darley Abbey Mills.

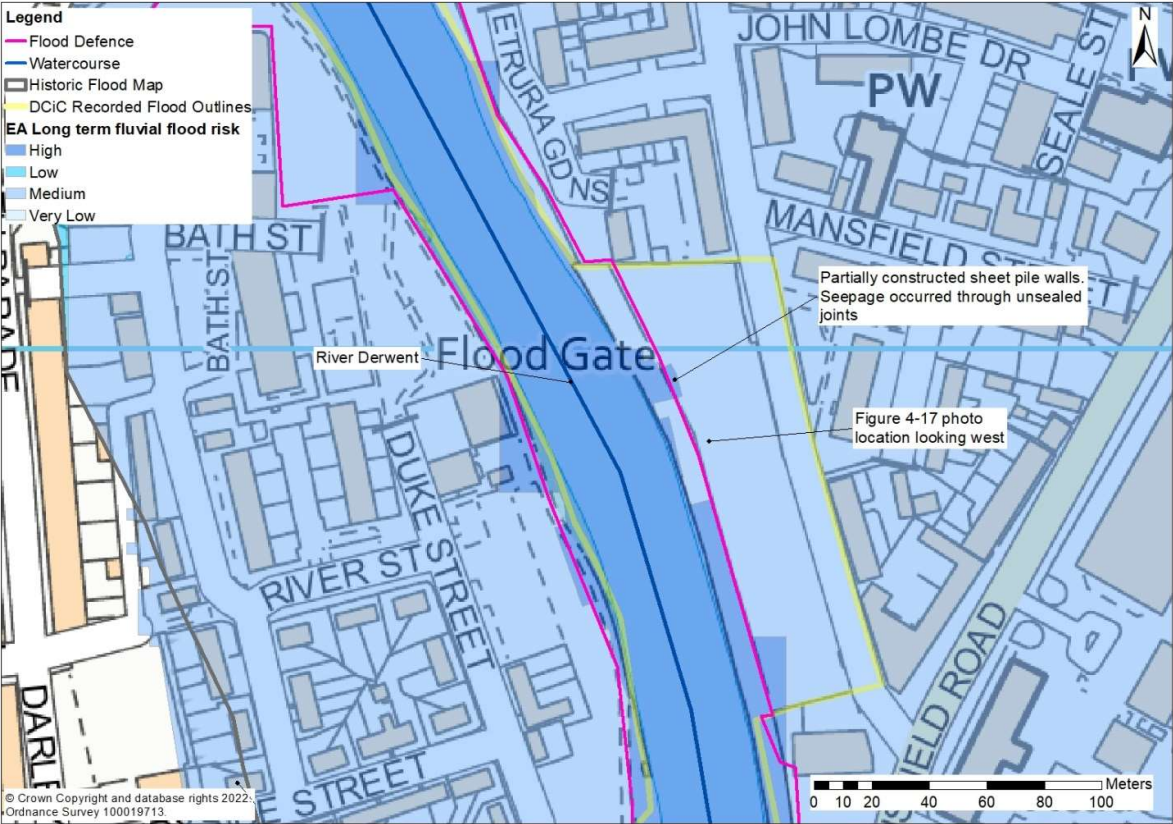
Figure 5-17: City Road flood defences

As part of the 'OCOR scheme'<sup>12</sup>, new sheet piling flood defences (see Figure 5-17) were in the process of being constructed along the riverbank behind Old Tomlinson Yard at the time of the flood event. At the time of the flooding event, the sheet piles had been installed however, the precast brick walls and concrete had not been installed and the sheet piles had not been sealed, resulting in seepage through the sheet piles (see Figure 5-18). includes the recorded flood outlines from DCiC however, there is some uncertainty with the outlines at this location as they appear to show there was no flooding from the river which does not match with the observed event.

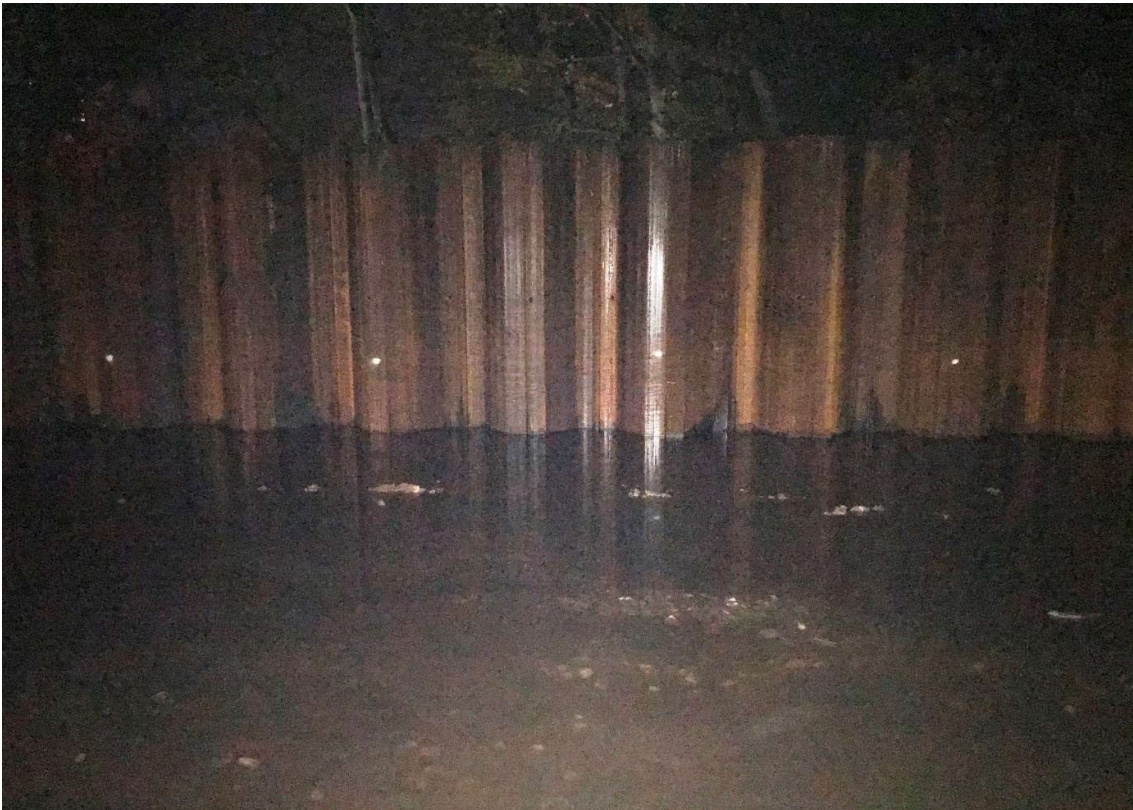
Figure 5-18: Seepage through sheet pile walls on City Road (21:22 8<sup>th</sup> November 2019)

To manage the seepage two pumps were used, a 4" and a 6", to pump the water out of the construction site and back to the River Derwent. During the flood event, the 6" pump failed resulting in flood water flowing onto City Road. Sandbags were then employed along City Road to protect the residential and commercial properties and as a result no internal flooding was reported. The reported flooding within the construction site and along City Road was of depths up to 50mm.

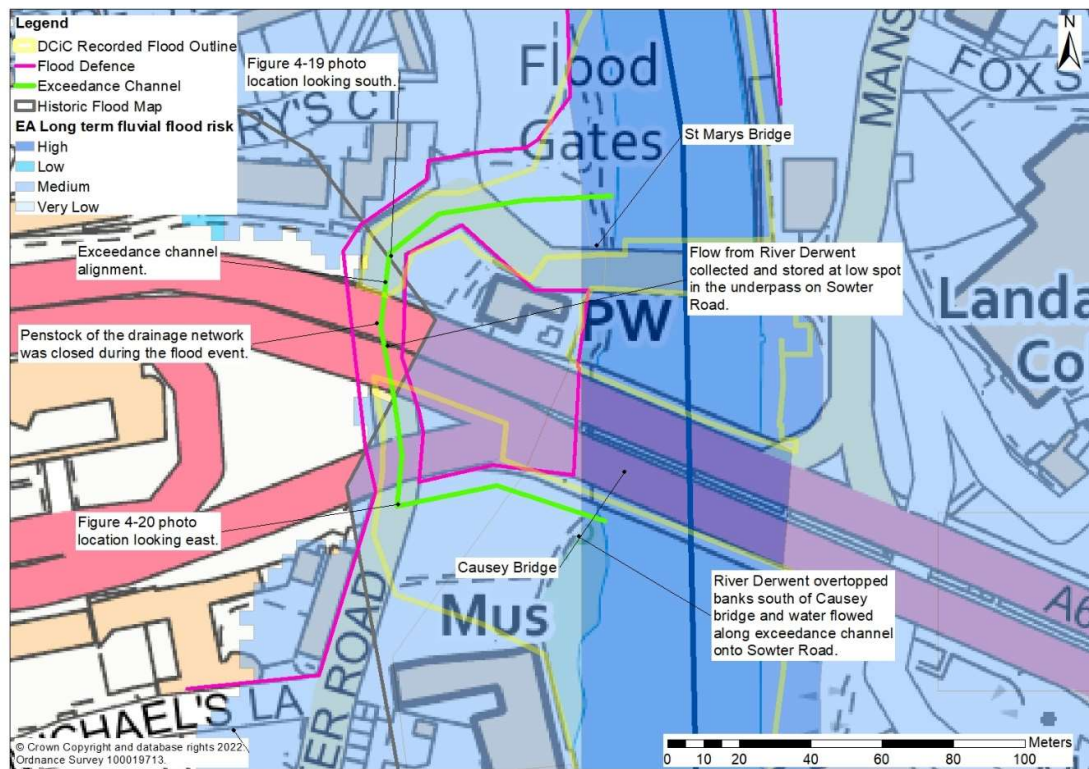
Figure 5-19: Recorded flood outlines at Sowter Road

Prior to this flood event as part of the OCOR scheme<sup>12</sup> to reduce the impact of St Marys bridge on river flow, an exceedance channel along Sowter Road was created, see Figure 5-19. The exceedance channel was designed to have flood waters overtop the bank and enter the channel north of the bridge allowing flows to bypass the constriction of St Marys Bridge and re-enter the channel south of the bridge, with flood water being stored under the underpass on Sowter Road. However, due to the levels of the constructed exceedance channel south of the bridge, the flood waters entered the exceedance channel from the south before collecting in the underpass, Figure 5-20 and Figure 5-21.

The manhole under the Sowter Road underpass (see Figure 5-19), is connected to a penstock which was shut to stop the flows entering the sewer system and allowing them to attenuate on the road. Due to the attenuation under the underpass and the flood walls and gates functioning as designed, no internal property flooding was reported in this area. After the river levels had reduced, the penstock was gradually reopened to allow the attenuated water to gradually enter the drainage system.

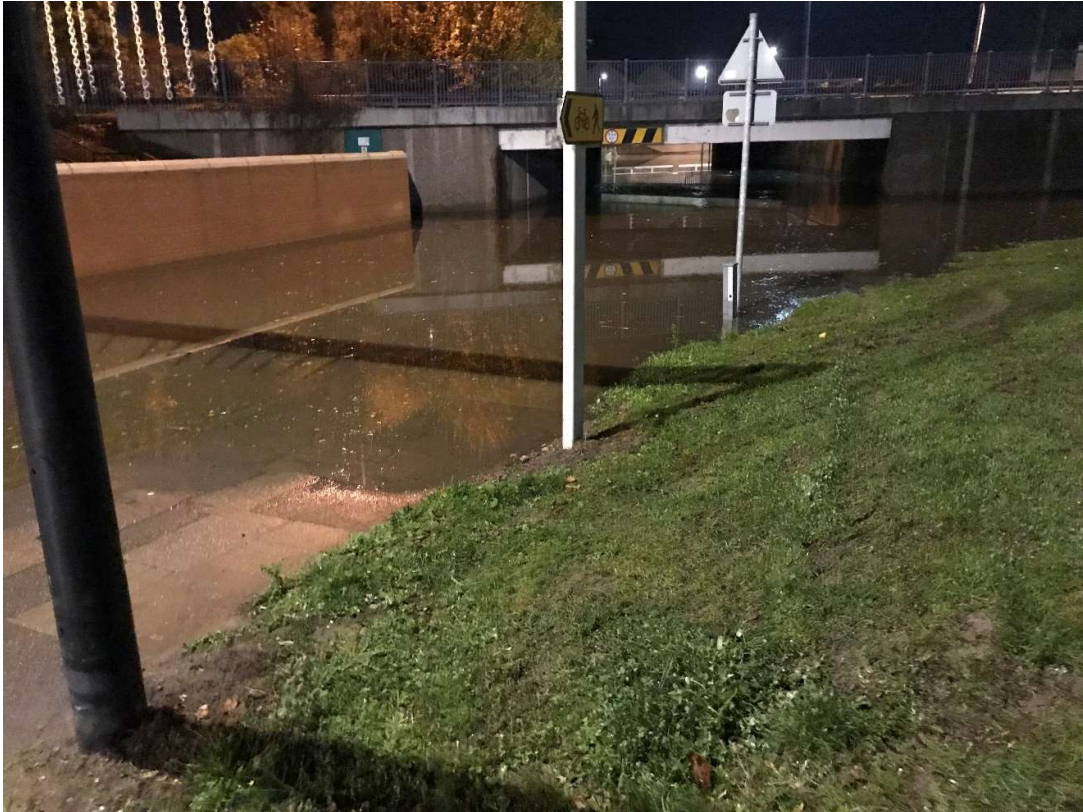
Figure 5-20: Flooding in Sowter Road underpass (22:57 8<sup>th</sup> November 2019)

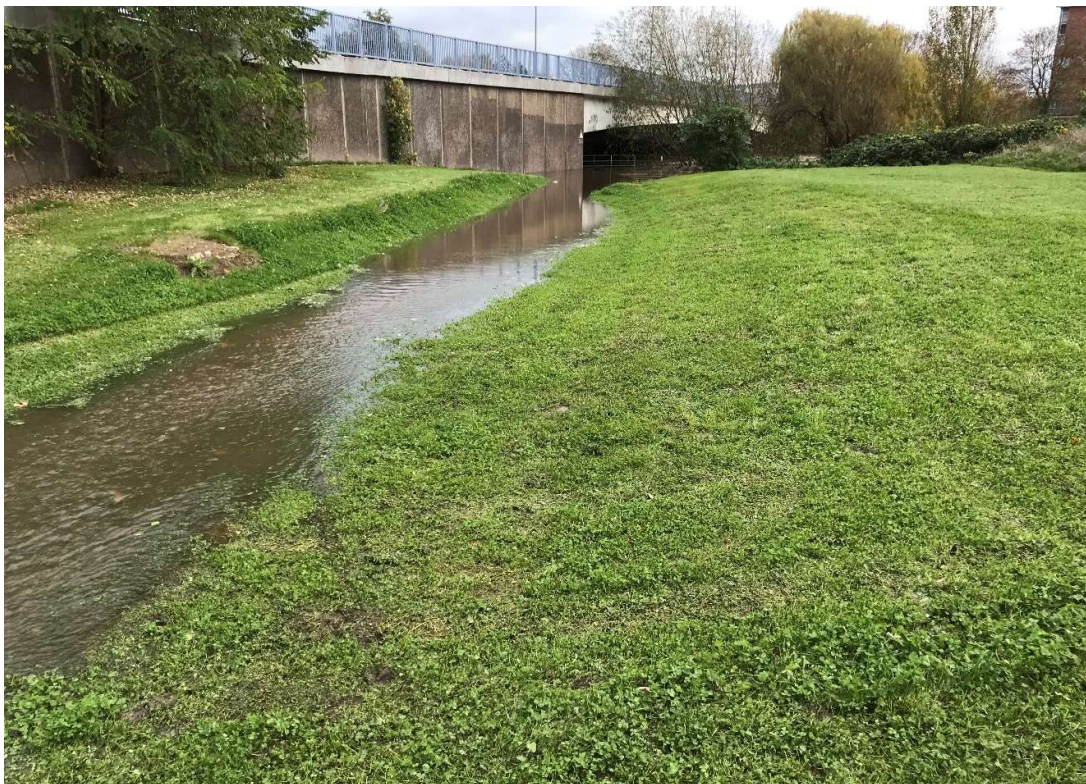
Figure 5-21: Exceedance channel South of Causey Bridge (13:14 8<sup>th</sup> November 2019)

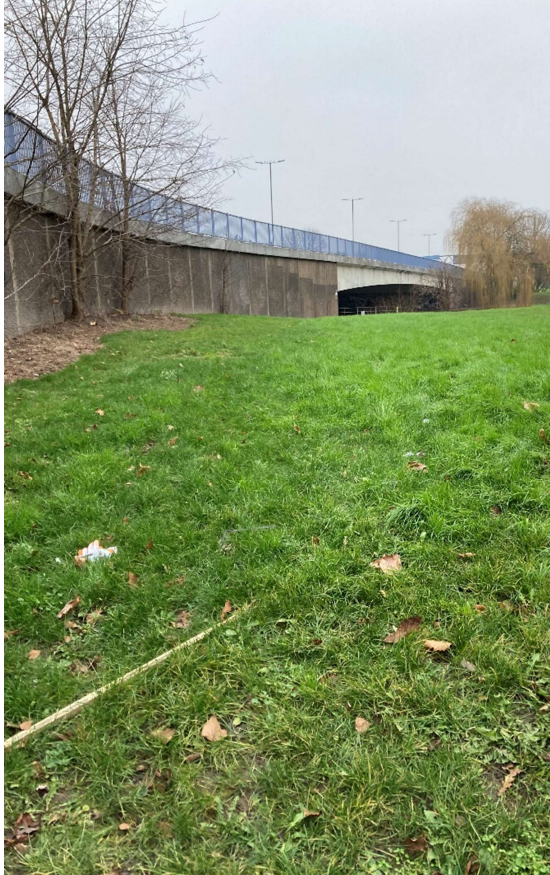
**Figure 5-22: Altered Sowter Road Exceedance Channel (January 2022)**

Since November 2019, DCiC have taken corrective action to ensure the exceedance channel will function as designed. The levels of the exceedance channel to the south of the bridge have been altered to match with the designed levels to reduce the chance of flood waters entering the exceedance channel from the south, see Figure 5-22.

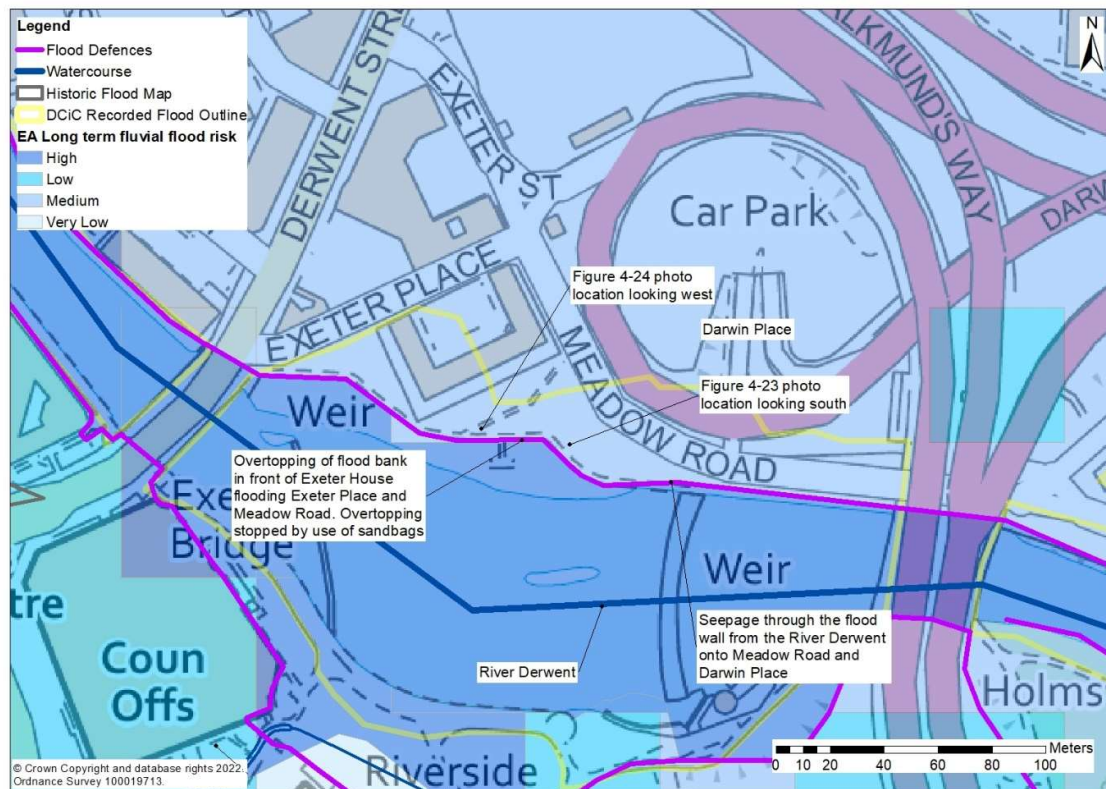
**Figure 5-23: November 2019 Recorded flood outlines at Exeter Place**

Figure 5-23 shows the flood defences around Exeter Place and Meadow Road west of Holmes bridge. It is understood the initial issue during the flood event was significant seepage through the floodwall along the riverside footpath (see Figure 5-24). This seepage is thought to have resulted in flooding on Meadow Road, with flood depths exceeding 2m in the lowest spot. The seepage through the flood wall is also reported to have resulted in flooding in Darwin Place with flood depths of up to 50mm.

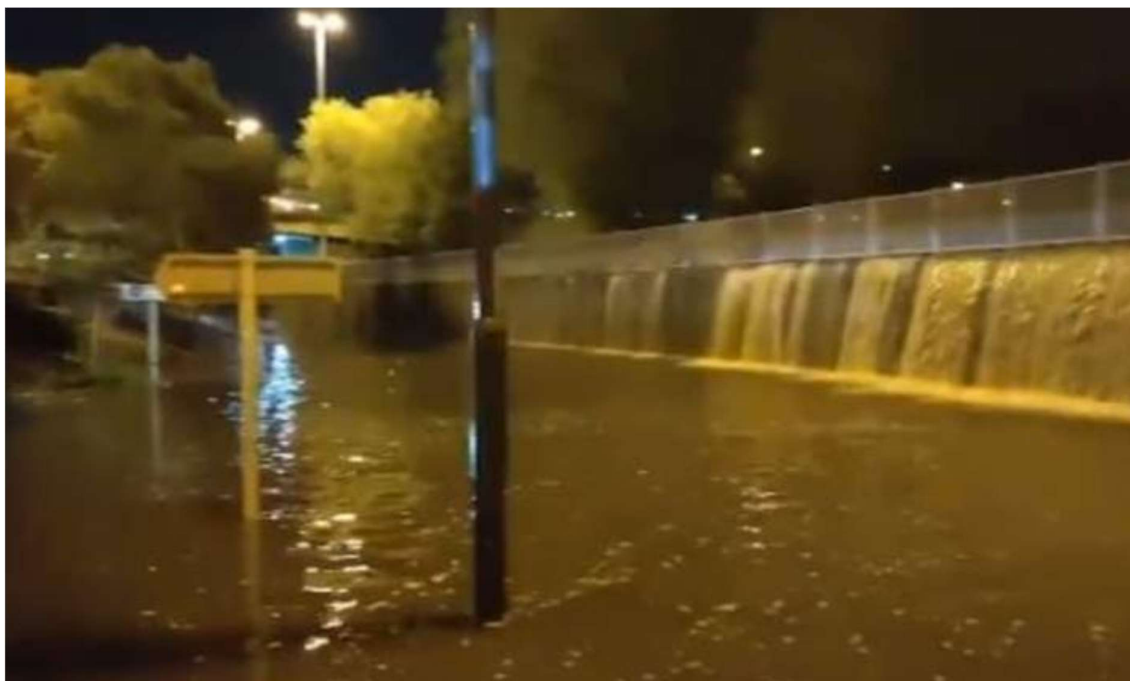
**Figure 5-24: Flooding on Meadow Road from seepage of water through flood wall. (8<sup>th</sup> November 2019).**

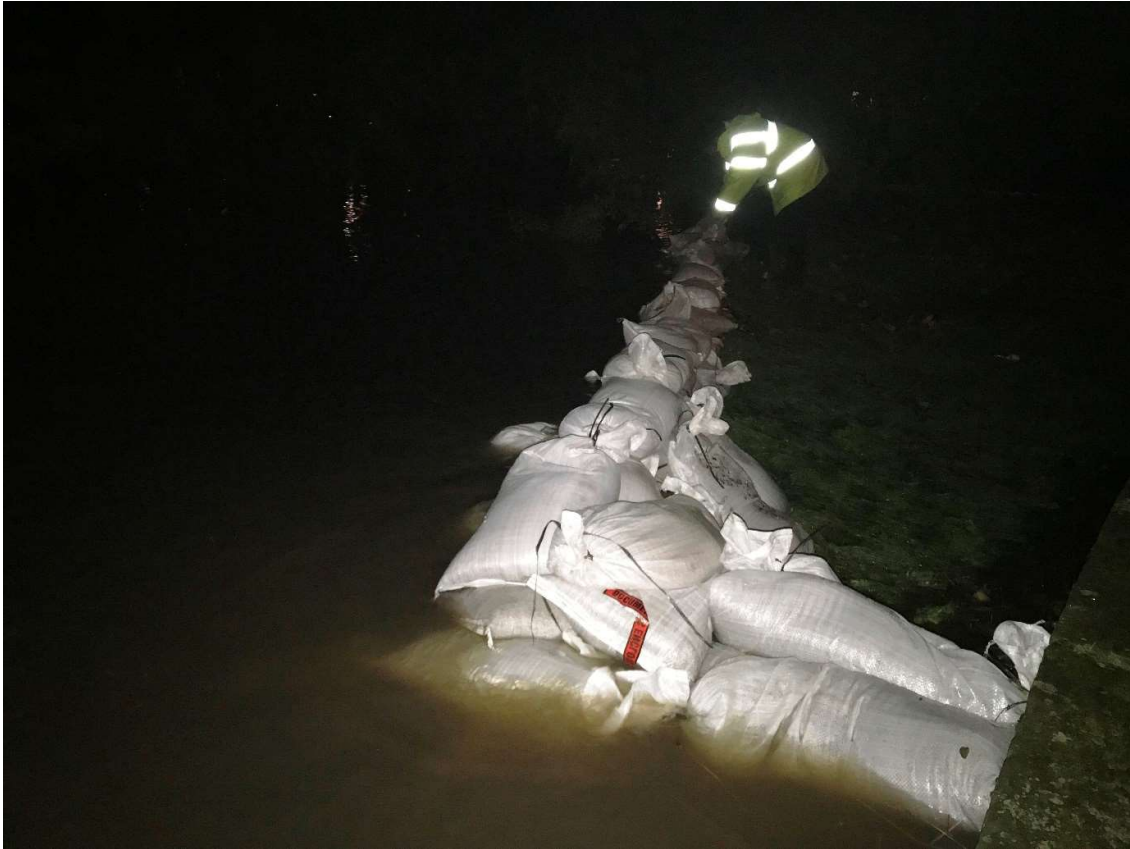
In addition to the seepage through the flood defences, the flood bank located in front of Exeter House was overtopped as river levels rose resulting in flood water flowing onto Exeter Place and also onto Meadow Road. DCiC deployed sandbags along the top of the flood bank as well as where the flood bank and flood wall meet (see Figure 5-25), which contained the flood waters and prevented further overtopping. No internal flooding was reported at Exeter Place or Meadow Road.

**Figure 5-25: Sandbags being deployed at Exeter Place (20:41 8<sup>th</sup> November 2019)**

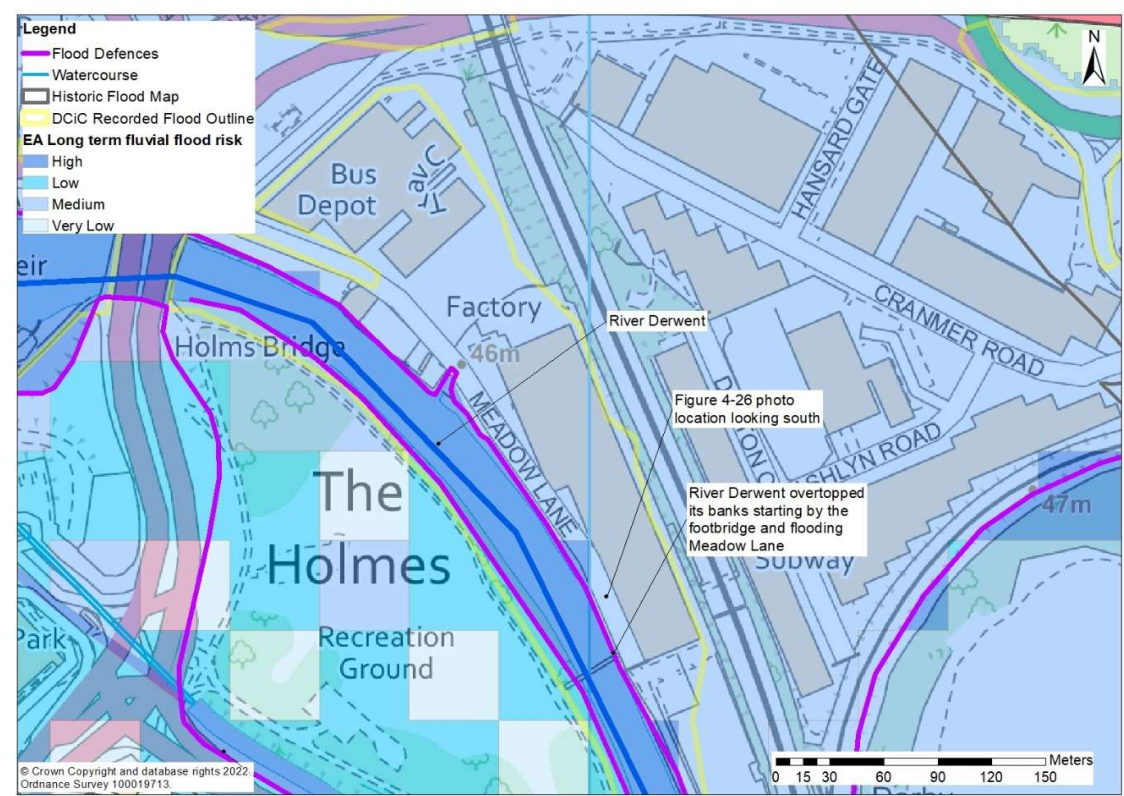
Figure 5-26: November 2019 Recorded flood outlines at Meadow Lane

The flooding that occurred along the industrial area of Meadow Lane was likely caused by the river overtopping its banks, starting by the footbridge, which acted as a constriction on the river flows. As identified by the EA's fluvial flood map, this area has a high risk of fluvial flooding (see Figure 5-26). As a result of the flooding one of the commercial properties was evacuated. The overtopping of the riverbank likely resulted in flooding of the road (see Figure 5-27).with flood depths of approximately 150mm to 200mm near the bridge by 2:30pm on 8<sup>th</sup> of November, 2019. From the site walkover it is understood that internal flooding at four of the commercial properties was experienced during the same event at this location.

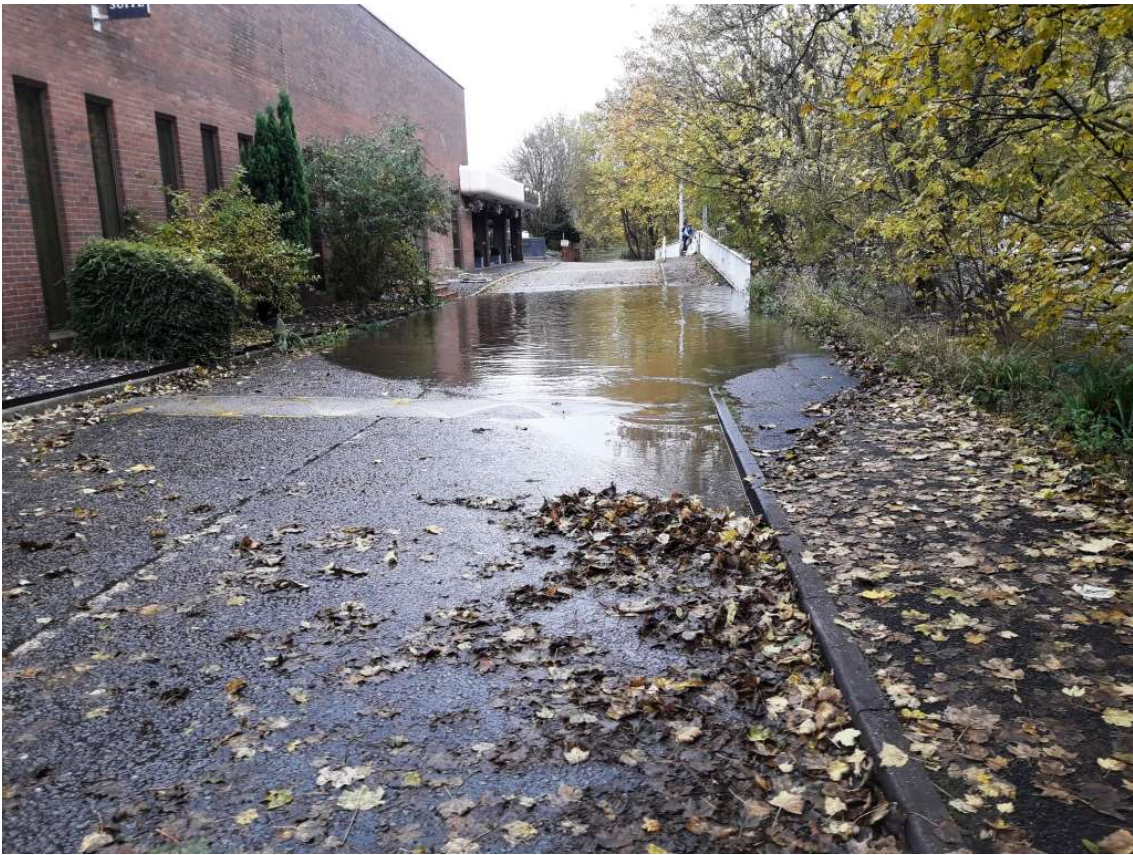
Figure 5-27: Flooding on Meadow Lane from overtopping of riverbank prior to the peak (13:58 8<sup>th</sup> November 2019)

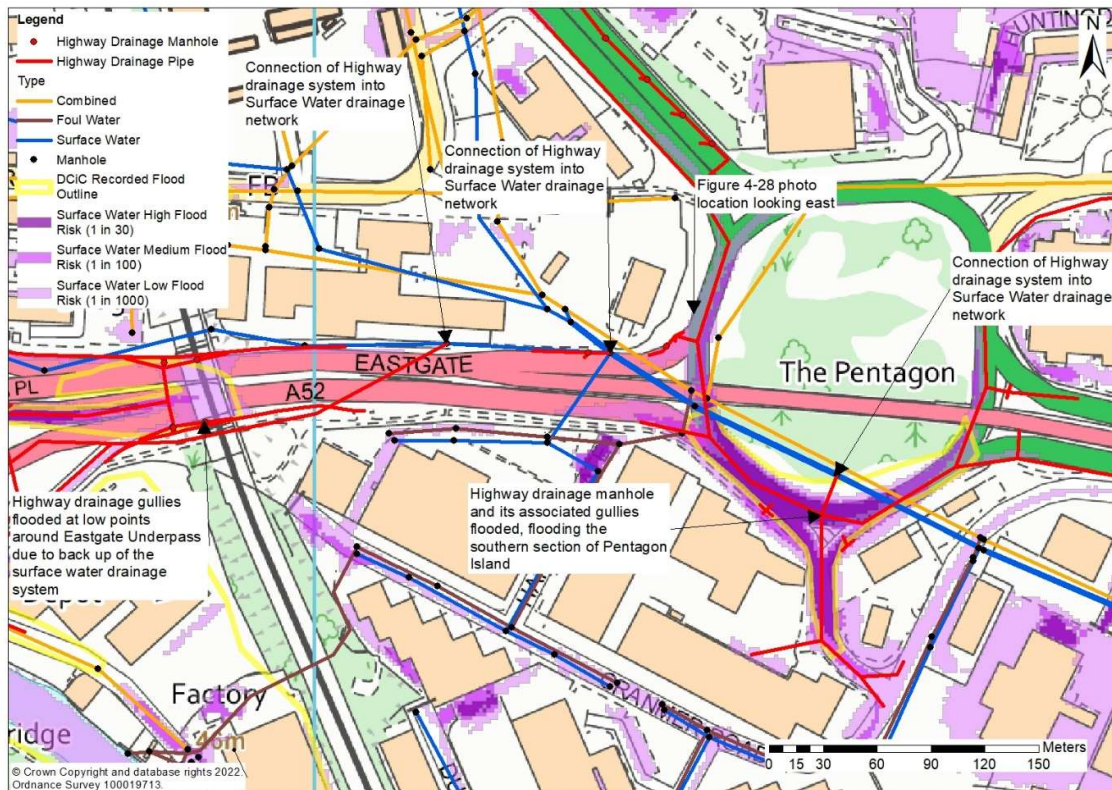
**Figure 5-28: November 2019 Recorded flood outlines at Pentagon Island and Eastgate Underpass**

Figure 5-28 shows the highway and surface water drainage system around the Eastgate Underpass and Pentagon Island and the connection between the two systems. The highway drainage system discharges into the STW surface water drainage system at a number of locations, which in turn discharges into the River Derwent near Chequers Road. The outfall of this system does not have a non-return valve fitted at the discharge point into the River Derwent. Consequently, the high river levels during the flood event reportedly caused flows to back up within the surface water sewer. Due to the connection of the highway drainage system and surface water system (see Figure 5-28) this caused high water levels within the highway drainage system as well, even without significant rainfall within the city. This resulted in water flooding out of the highway drainage manholes and gullies at low spots away from the river, flooding the southside of Pentagon Island roundabout.

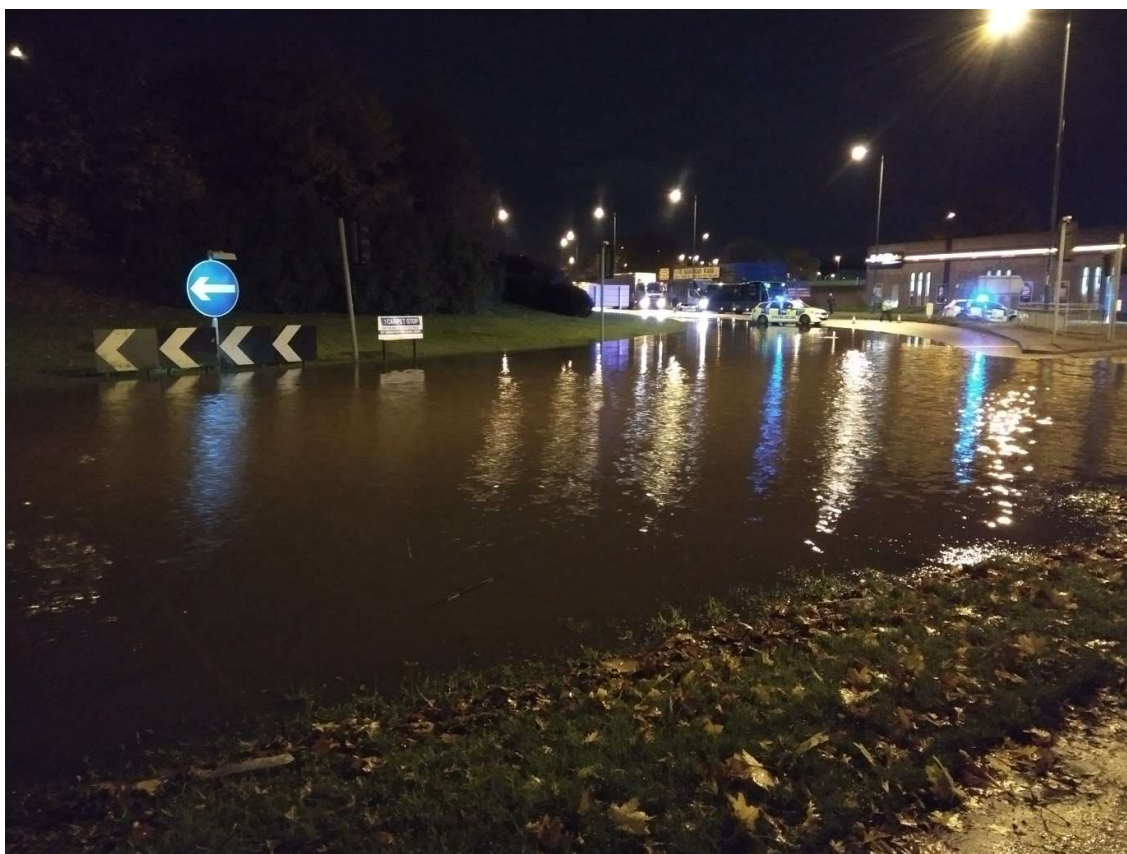
The flooding (see Figure 5-29) resulted in Pentagon Island being closed at the A52 Slip Road Nottingham bound to St Alkmunds way at 23:20 on 8<sup>th</sup> November before being reopened at 04:26 on 9<sup>th</sup> November after it was clear of water.

**Figure 5-29: Pentagon Island flooding before peak (17:40 8<sup>th</sup> November 2019)**

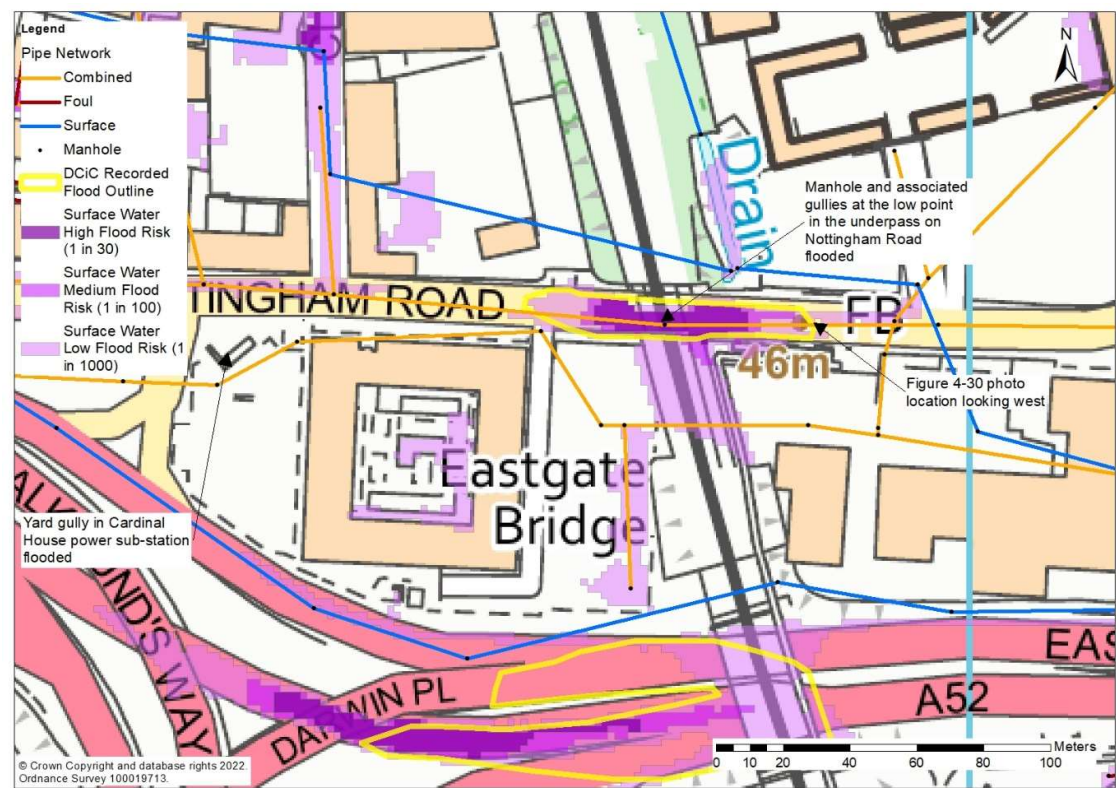
Figure 5-30: November 2019 Recorded Flood Outlines at Cardinal House

Figure 5-30 shows the combined drainage systems for Cardinal House and along Nottingham Road. The combined drainage system is shown to have a hydraulic connection into the surface water system mentioned in Section 5.2.9 at a manhole to the east of Cardinal House (Location SK36361507), assumed to be a combined sewer overflow. As stated previously, the surface water system backed up from the outfall due to the high river levels. The connection of the surface water system and combined system led to the combined system also backing up resulting in the gullies in Cardinal House and along Nottingham Road flooding. The underpass on Nottingham Road and the below ground sub-station in Cardinal Square are low points in the topography (see Figure 5-30), and so due to the high river levels the gullies on Nottingham Road and the yard gully within the substation flooded. This is understood to have resulted in flood depths of greater than 130mm, see Figure 5-31. As shown in Figure 5-30, the recorded flood outlines from the event broadly match the area at low to high risk from surface water flooding in this area.

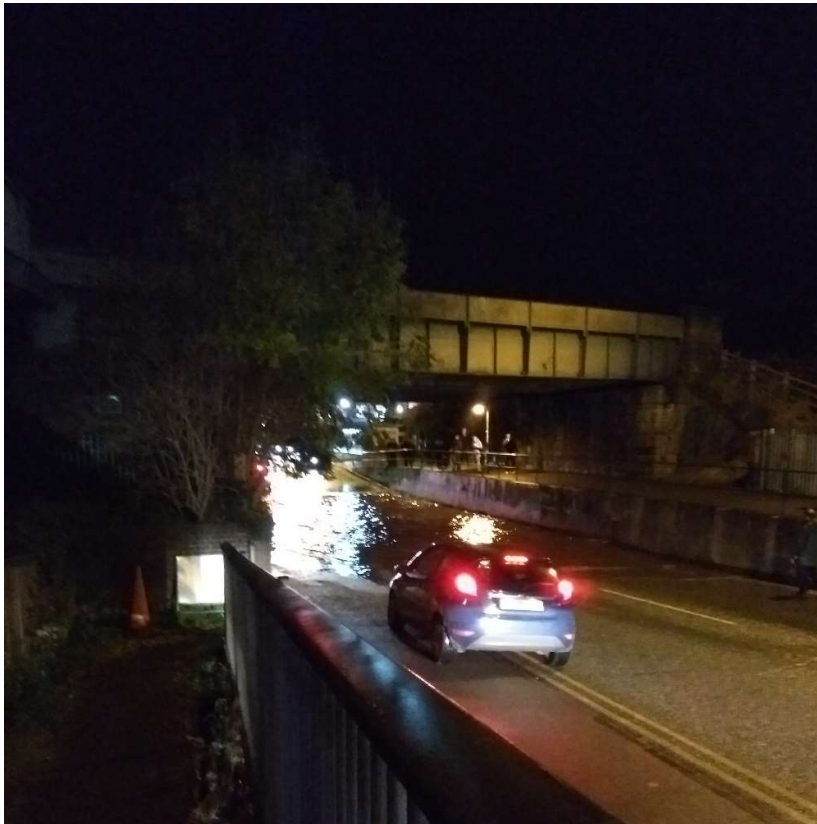
Figure 5-31: Flooding in underpass on Nottingham Road (17:47 8<sup>th</sup> November 2019)

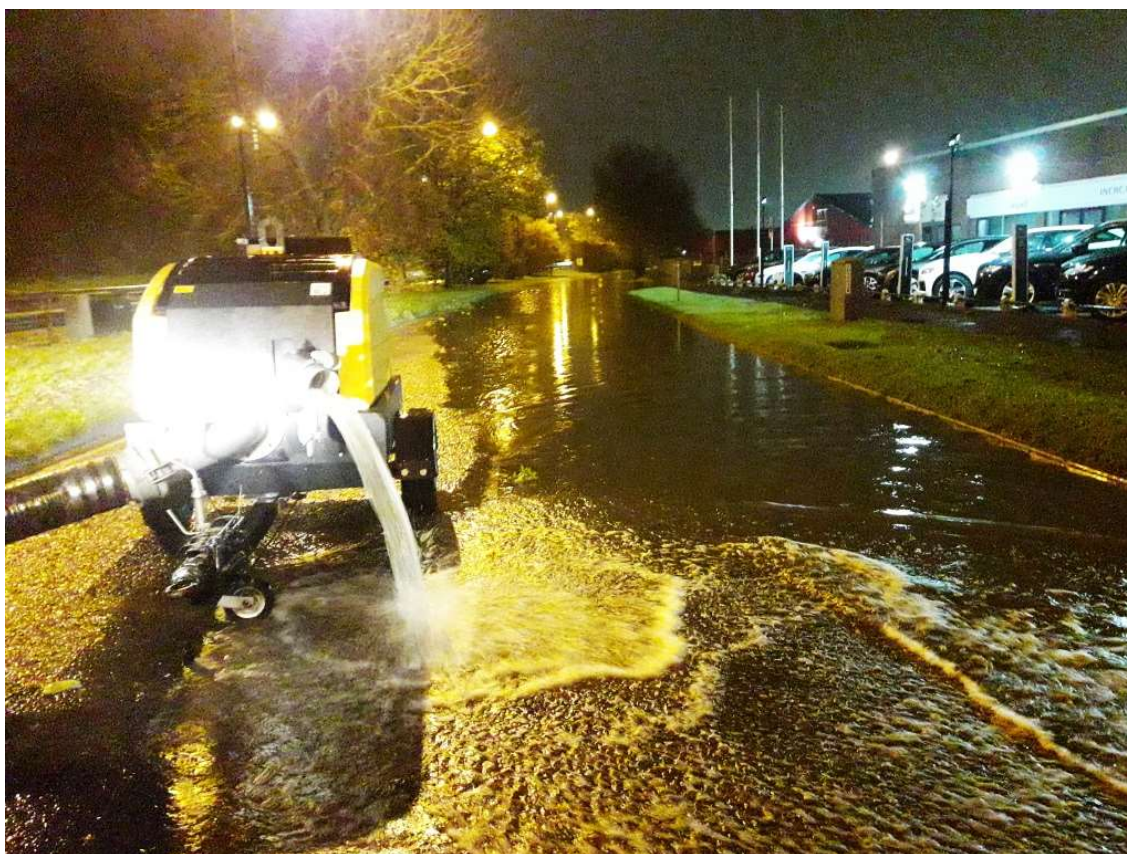
The flooding in the Chaddesden Sidings area resulted in flooding of the A52 and Chequers Road (see Figure 5-32) and internal flooding to several commercial properties along Chequers Road up to a depth of 1.5 m. The A52 which runs east - west to the north of this area was closed from 21:45 on 8<sup>th</sup> November and reopened on 9<sup>th</sup> November. Chequers Road was also closed at 07:41 on 9<sup>th</sup> November due to flooding within the carriageway. The flooding within Chaddesden Sidings is thought to have had three sources, flooding from the south of the railway embankment, failure of the Downing Road pumping station and flooding from the STW surface water sewer backing up.

**Figure 5-32: Pumping in Chaddesden Sidings after flooding (18:39 9th November 2019)**

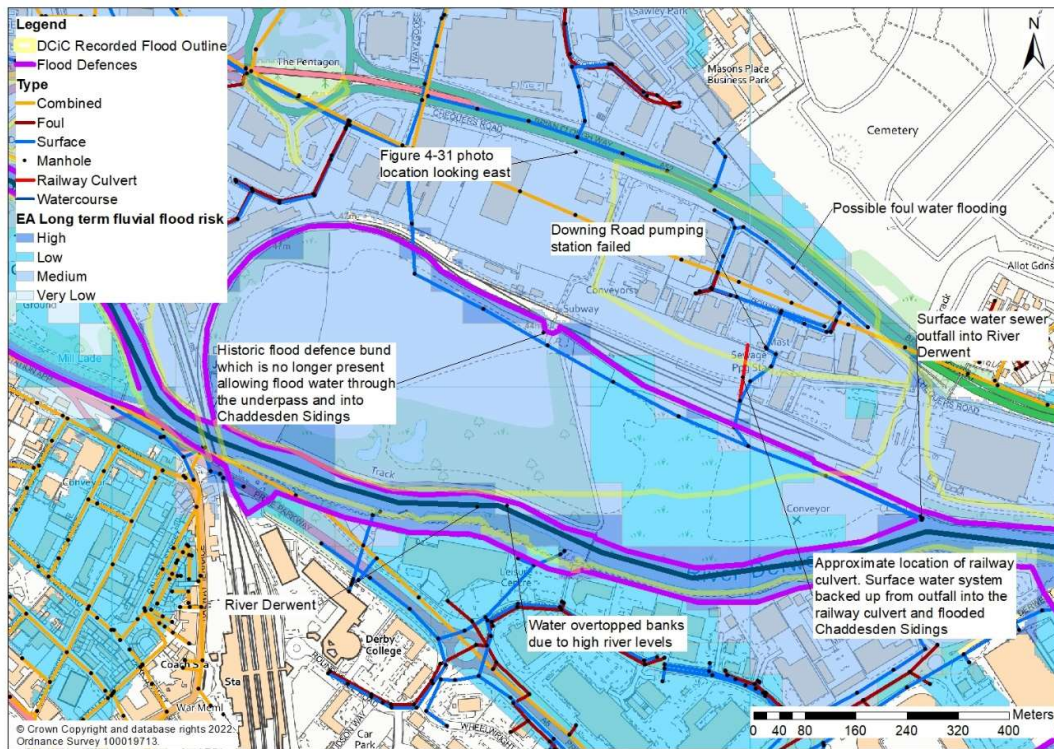
Figure 5-33: November 2019 Recorded flood outlines at Chaddesden Sidings

During the flood event, flooding occurred across the flood plain, with the River Derwent overtopping its banks and flooding the area to the south of the railway tracks. Although the railway lines act as a flood embankment, preventing water from flowing further north, there is an underpass which allowed flood water to flow into Chaddesden Sidings, see Figure 5-33. A flood defence bund was previously constructed to maintain the defences and protect the underpass from fluvial flooding, see Figure 5-34. The EA are in charge of maintaining the flood defence bund. However, prior to the November 2019 event the bund was either removed or eroded, leaving a gap within the flood defences. This allowed flooding from the flood plain into Chaddesden Sidings.

The outfall of the surface water drainage system has been discussed between the EA, DCiC and STW and as part of the OCOR Scheme<sup>12</sup>, the flood defences around Chaddesden Sidings are proposed to be upgraded. The flood defences are expected to replace the need for the old flood defence bund that protected the railway underpass. While the design for this phase has not been finalised, the need for a non-return valve and a pumping station at the outfall of the surface water network has been acknowledged and funding is being sought.
