# Investigation Report into November 2019 Derwent Floods in Derby City

Derby City Council

Project number: 60675186

15th September 2022

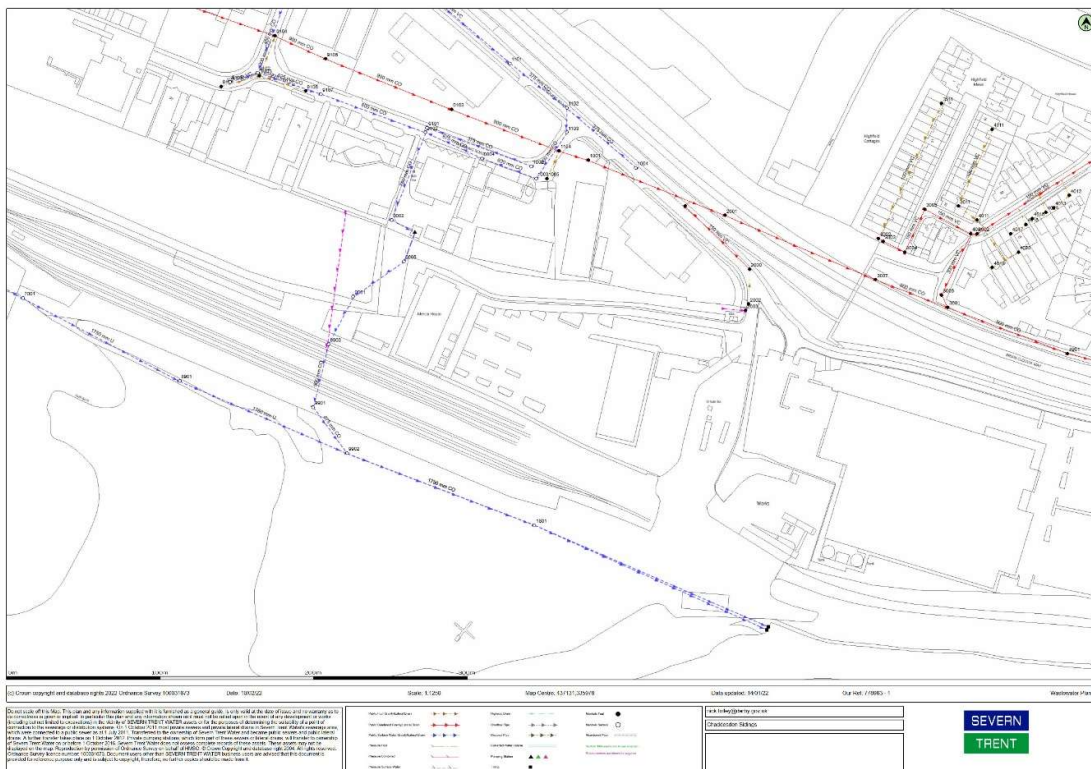
Figure 5-35: STW Sewer records within the Chaddesden Sidings Area

In addition to the mechanism above, it became evident during the flood investigation that flooding also occurred north of the railway due to flows from the river backing up through the STW surface water sewer and an existing culvert underneath the railway, shown in Figure 5-33 and Figure 5-35. The figures shows that the railway culvert is connected into the surface water drainage system, this is the same system referred to in Sections 5.2.9 and 5.2.10. Prior to this flood event the existence of the railway culvert was unknown, and it is believed that the railway culvert may have previously been blocked. Due to the open nature of the upstream end of the culvert, water was able to flow back from the river into the culvert and flood into Chaddesden Sidings, contributing to the flooding.

STW has reported that during the flood event the pumping station became flooded due to the significant flooding in area which led to the failure of the pump, which probably exacerbated the flooding in the area.

STW was notified by the equipment that the pumping station failed and repaired the pump after the flood event had occurred. Subsequent to this event, STW have undertaken work to upgrade and raise the control panel within the pumping station to improve its flood resilience.

It is believed that foul water flooding also occurred within this area, as it is a commonly observed issue that when flooding occurs a foul manhole in this area surcharges. This is a known issue and STW have undertaken cleansing works in the area subsequently to improve the attenuation of the system.

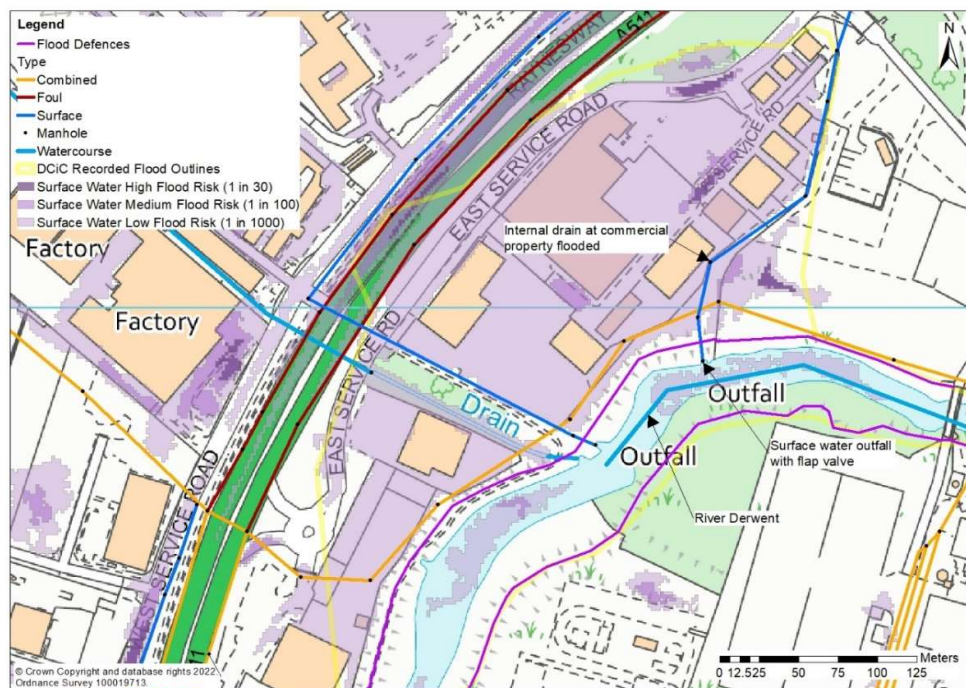
**Figure 5-37: November 2019 Recorded flood outlines at Raynesway (surface water flood risk)**

Figure 5-37 shows a second outfall into the river north of the ditch outfall, for a surface water drainage system. Due to the high river levels during the event the surface water system was also unable to discharge and so pluvial flows backed up along the pipe. This resulted in internal flooding of one commercial property on Raynesway as a drain located within the property flooded, see Figure 5-39.

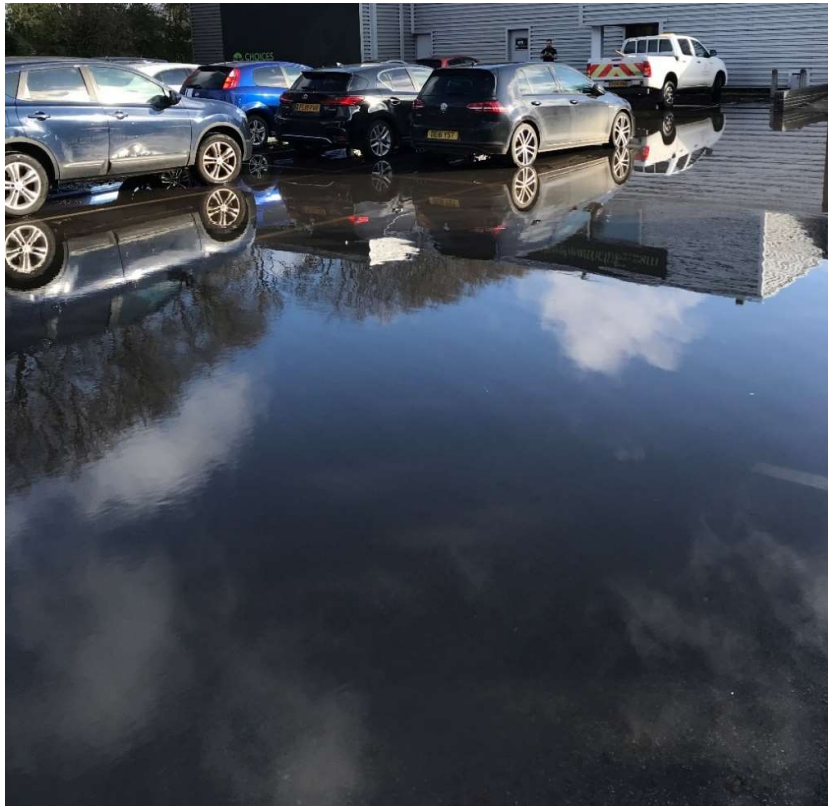
**Figure 5-38: Flooding within commercial property car park (10:49 8<sup>th</sup> November 2019)**

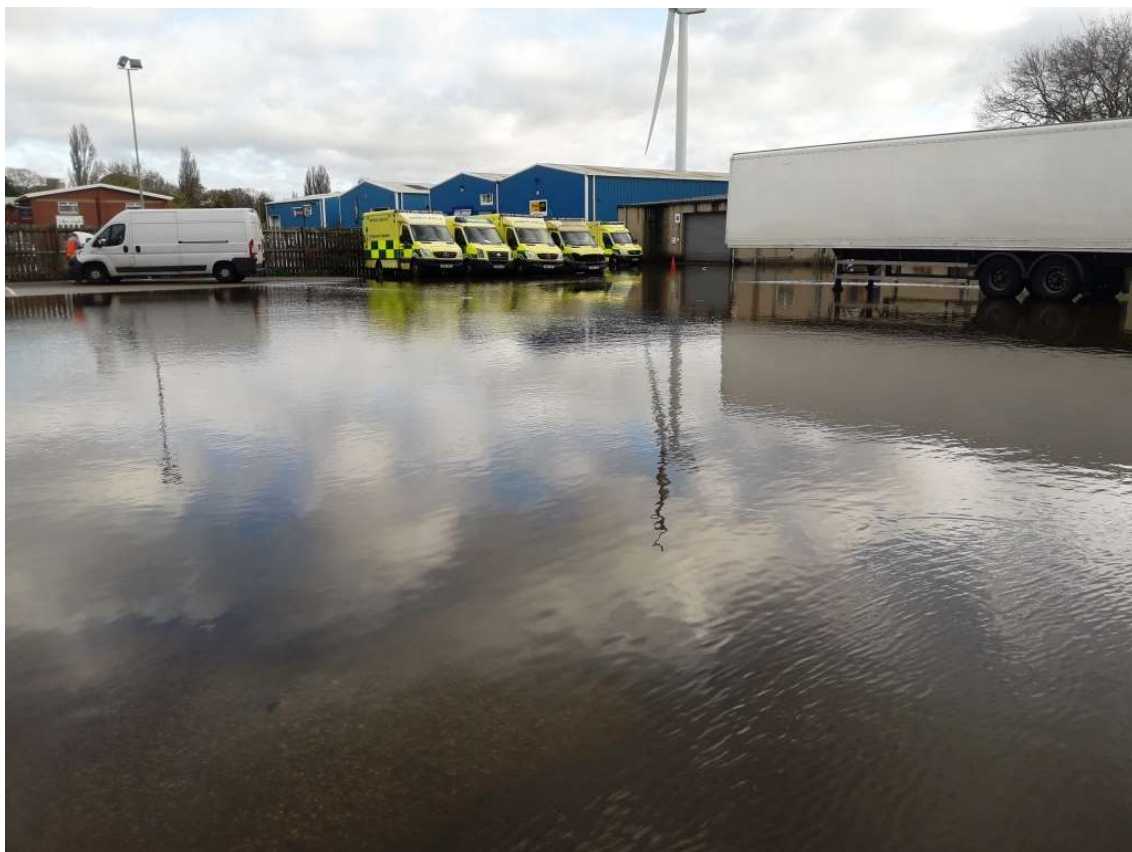
**Figure 5-39: Flooding at commercial property on Raynesway (11:09 8<sup>th</sup> November 2019)**
