Report on poplar trees at Sinfin Central Business Park Sinfin Lane, Derby

October 2005

SINFIN CENTRAL
BUSINESS PARK,
DERBY

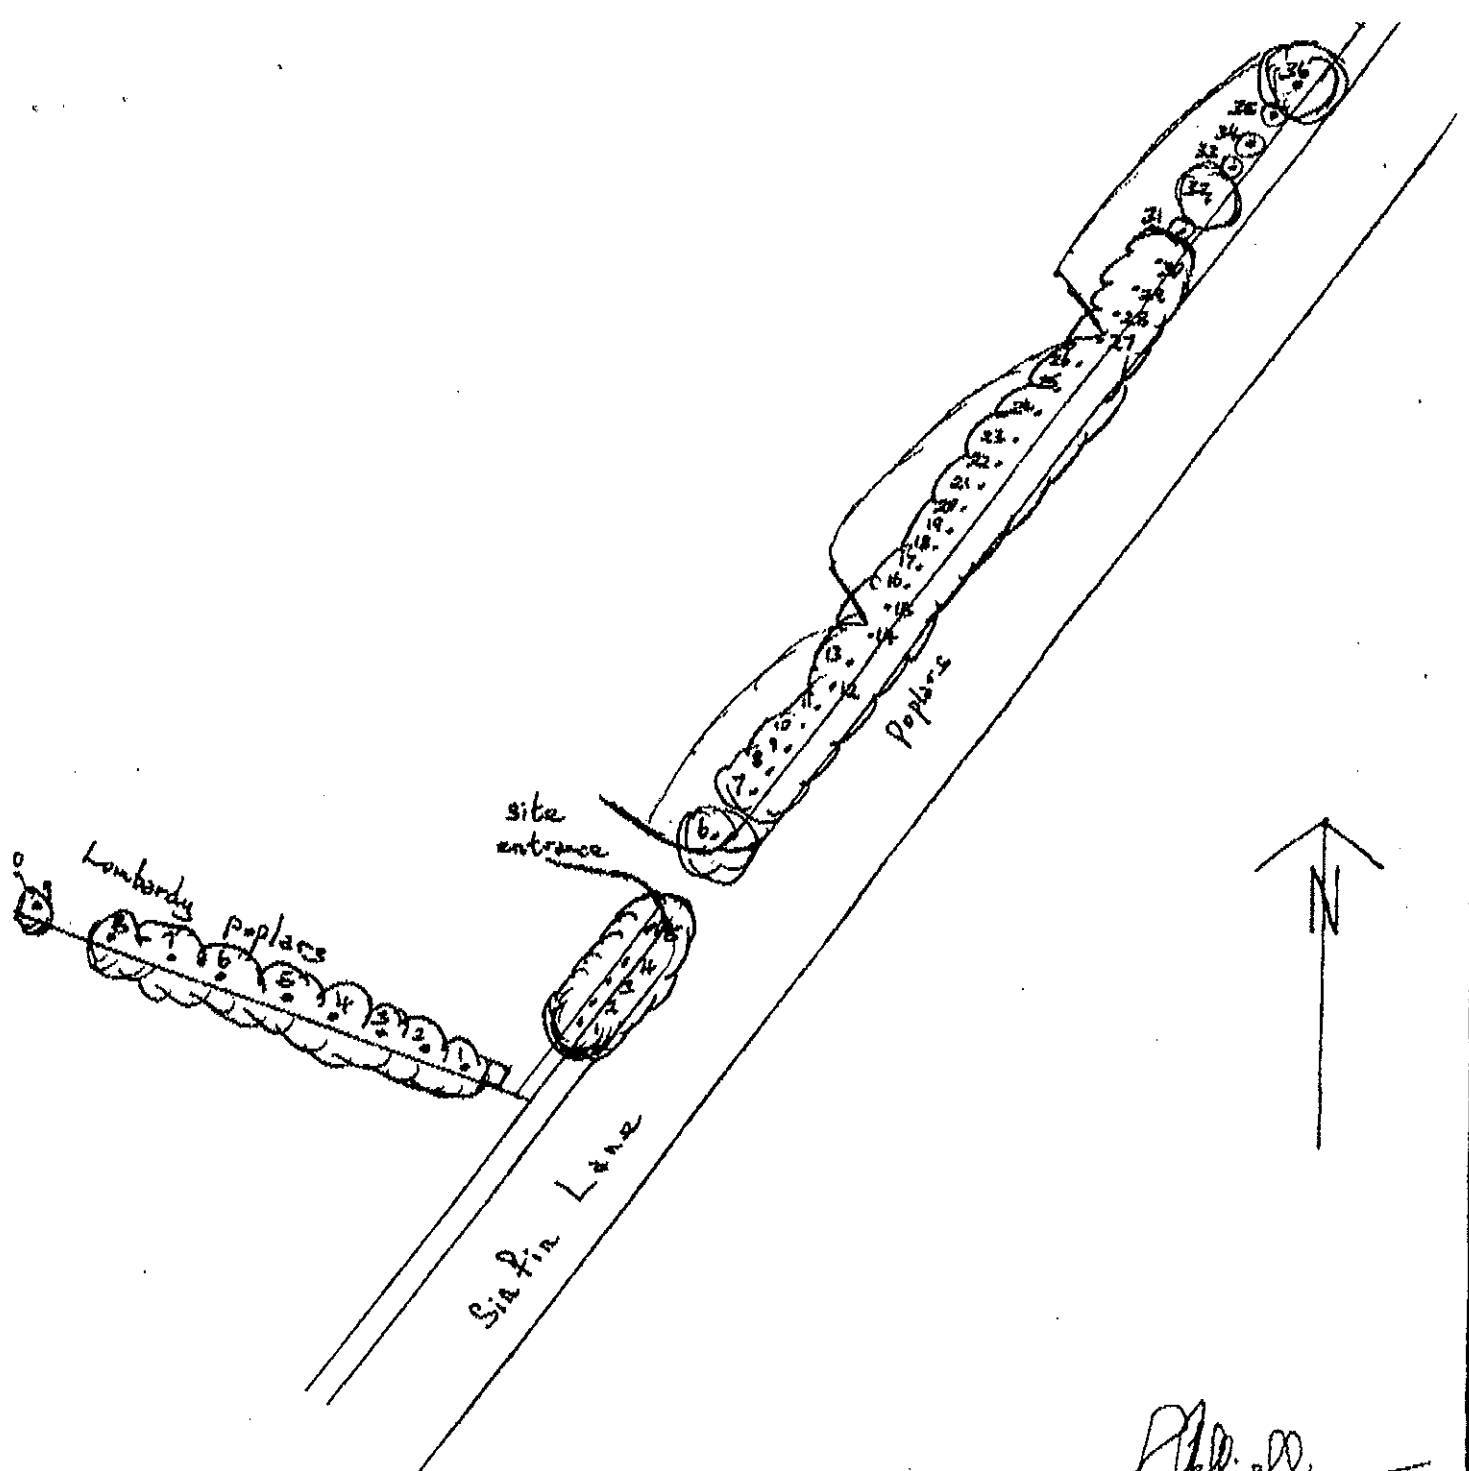
2.1 There are 32 black poplars (*Populus nigra*) and 4 Lombardy poplars (*Populus nigra* 'Italica') along the frontage with Sinfin Lane and 10 Lombardy poplars along the other boundary. These are illustrated approximately on the appended sketch plan.

3.6 If option b) is adopted, I would advise removing Lombardy poplar No. 9 (in the row of 10) and trees No.9 (21cm), 13 (34cm), 14 (42cm), 18 (34cm), 22 (37cm), 24 (40cm), 26 (34cm), 31 (21cm), 33 (22cm), 34 (30cm), and 35 (23cm). It may be sensible to remove more trees than this, but this would depend at least in part on where the new trees are to be planted.
