Appendix 2

Historic Examples and references

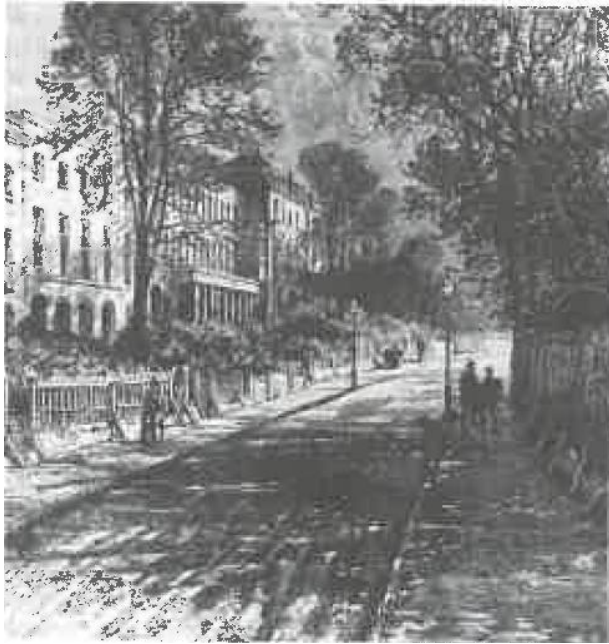
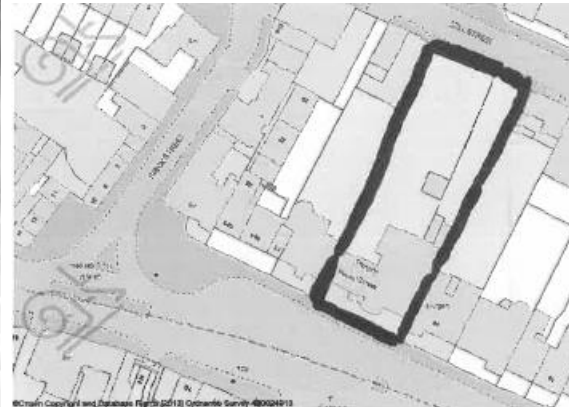
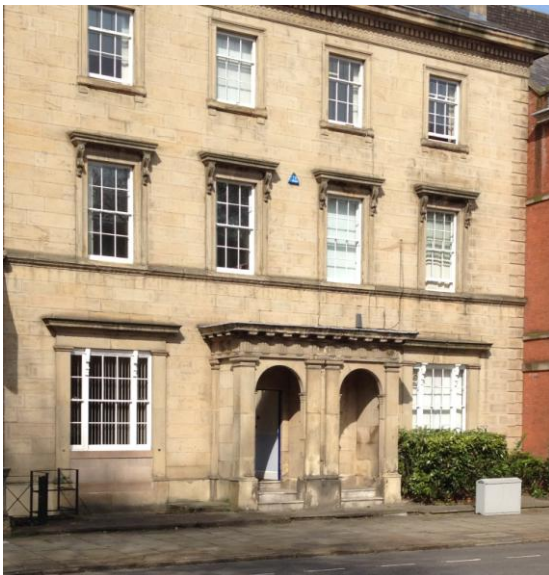
Top left Camberwell Grove note square porticos/ colonnades to façade of Georgian houses. Top right location near junction of Friar Gate and Brick St opposite Vernon St. Below a portico of the scale although used as doors seen at 47-49 Friar Gate and the façade of Friar Gate House showing the current and proposed situation

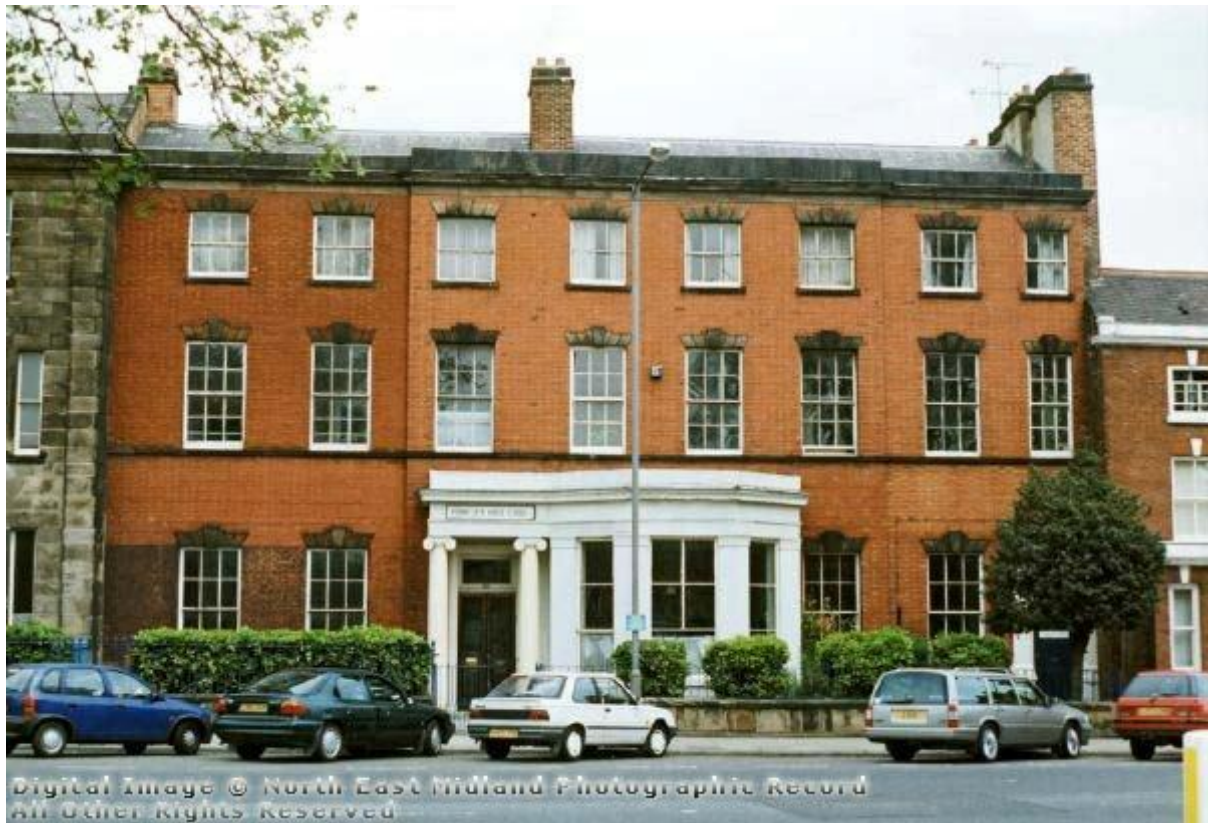
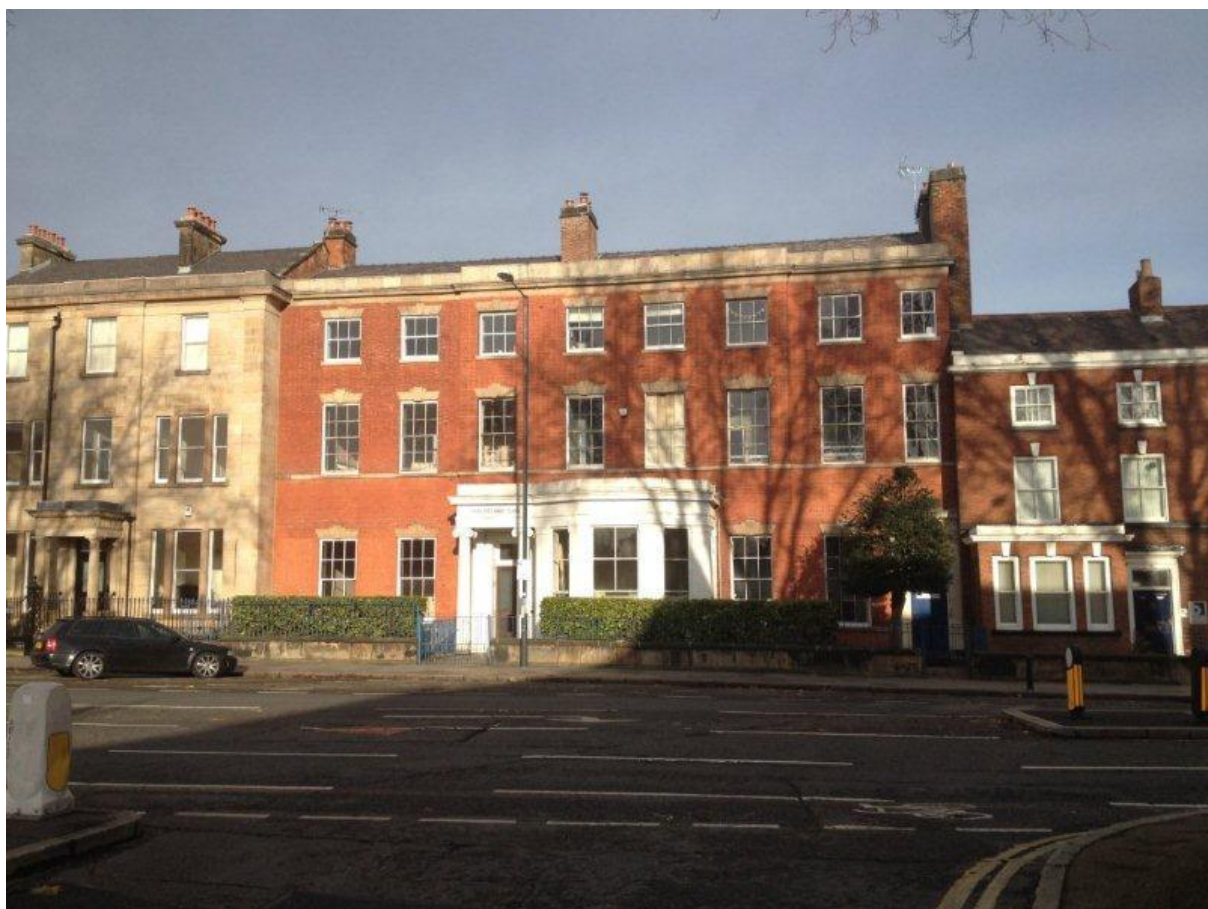
Friar Gate House Pre and Post cleaning. Fine stonework can now be appreciated.

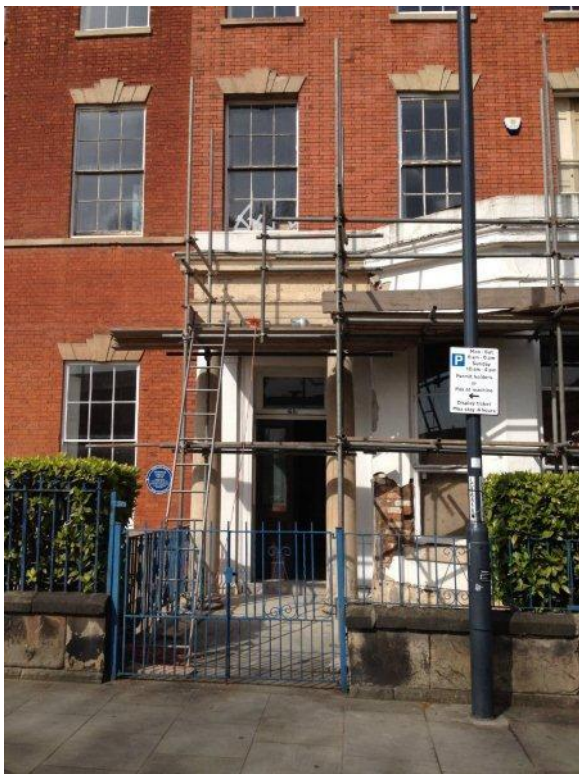
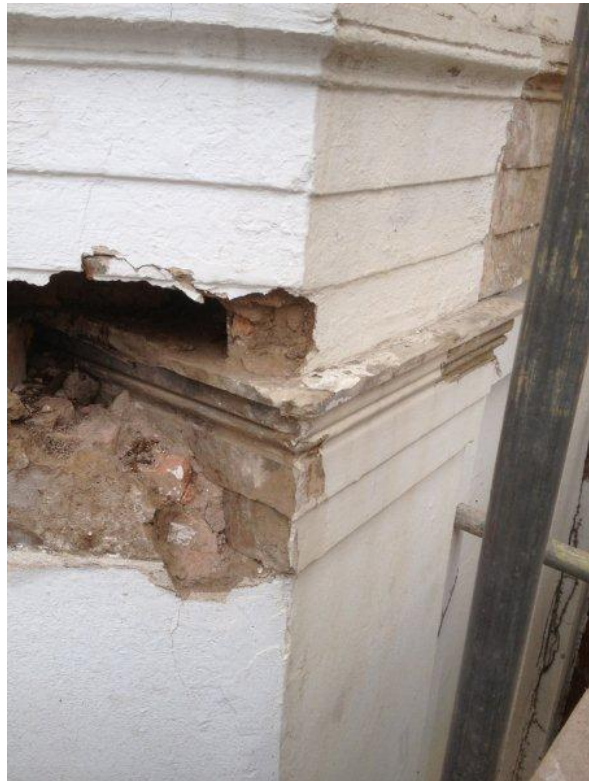
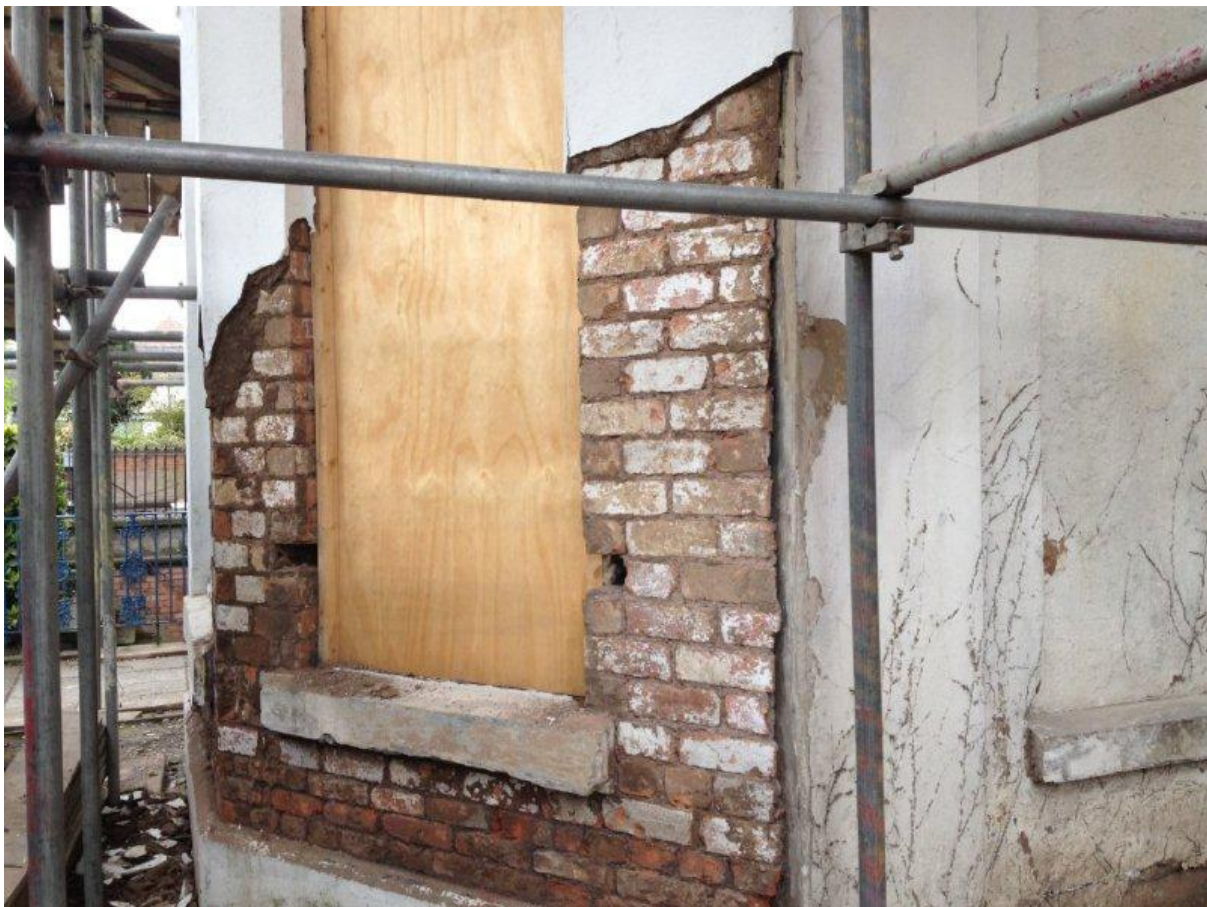
Top left Cleaned columns and portico exposing high quality stonework Top right exposed stone column behind bay Below exposed bricks not attached to original Georgian Stonework to rear

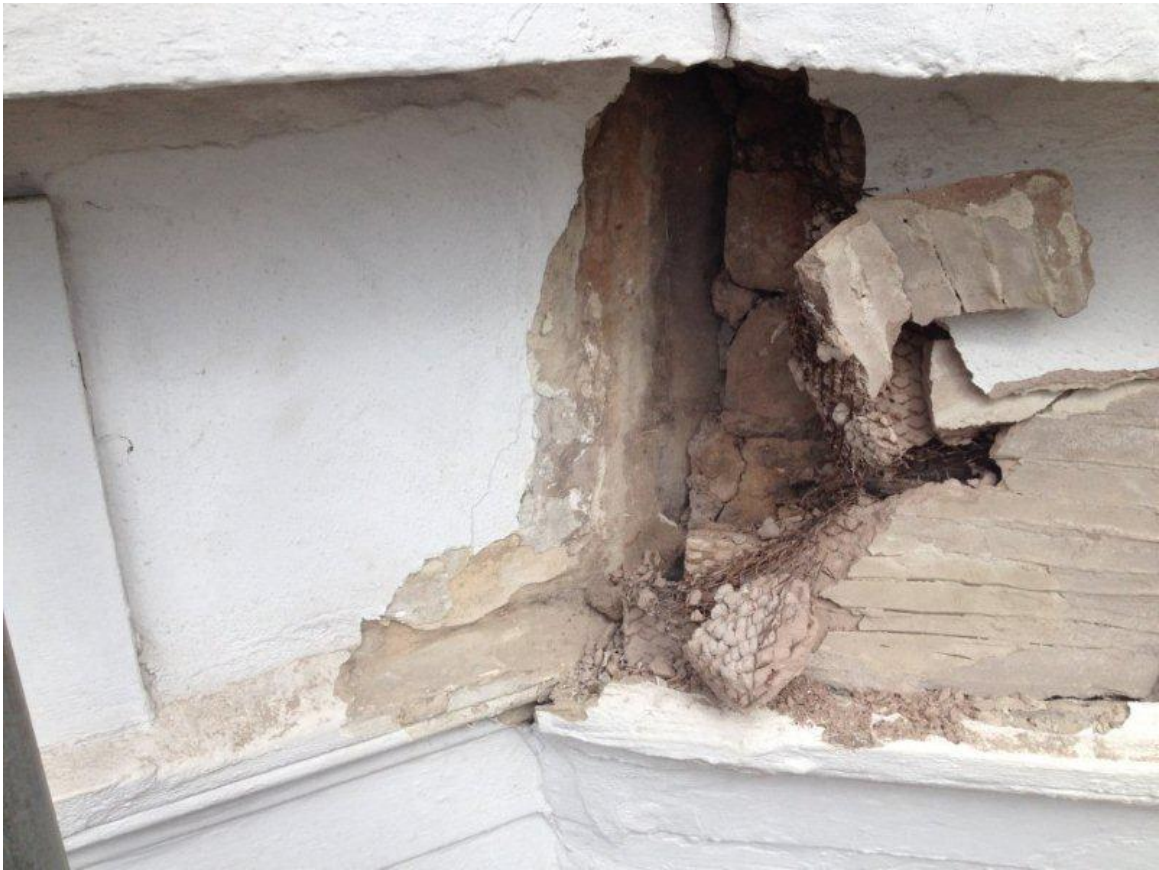
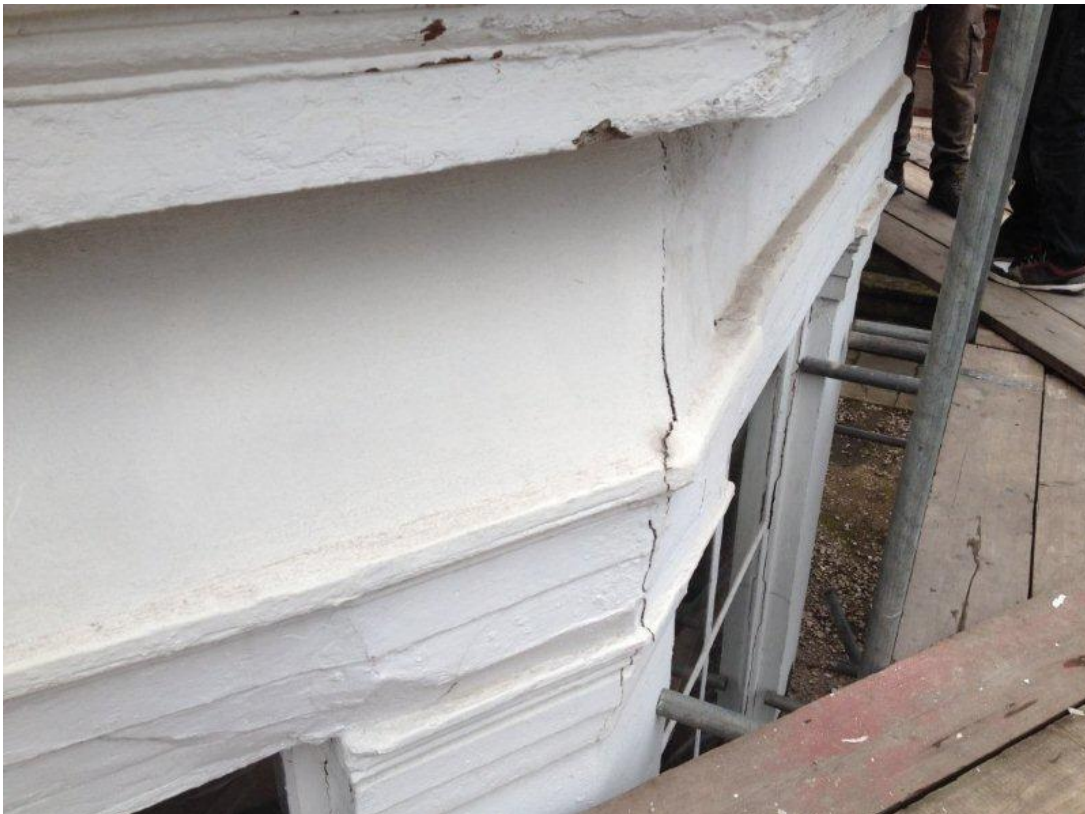
Modern Repair to clay element above at junction with stone of original portico and failing below
