DERBY CITY COUNCIL

APPENDIX 2

**Review of Speed Camera Locations
including trial use of
Speed Indicating Devices**

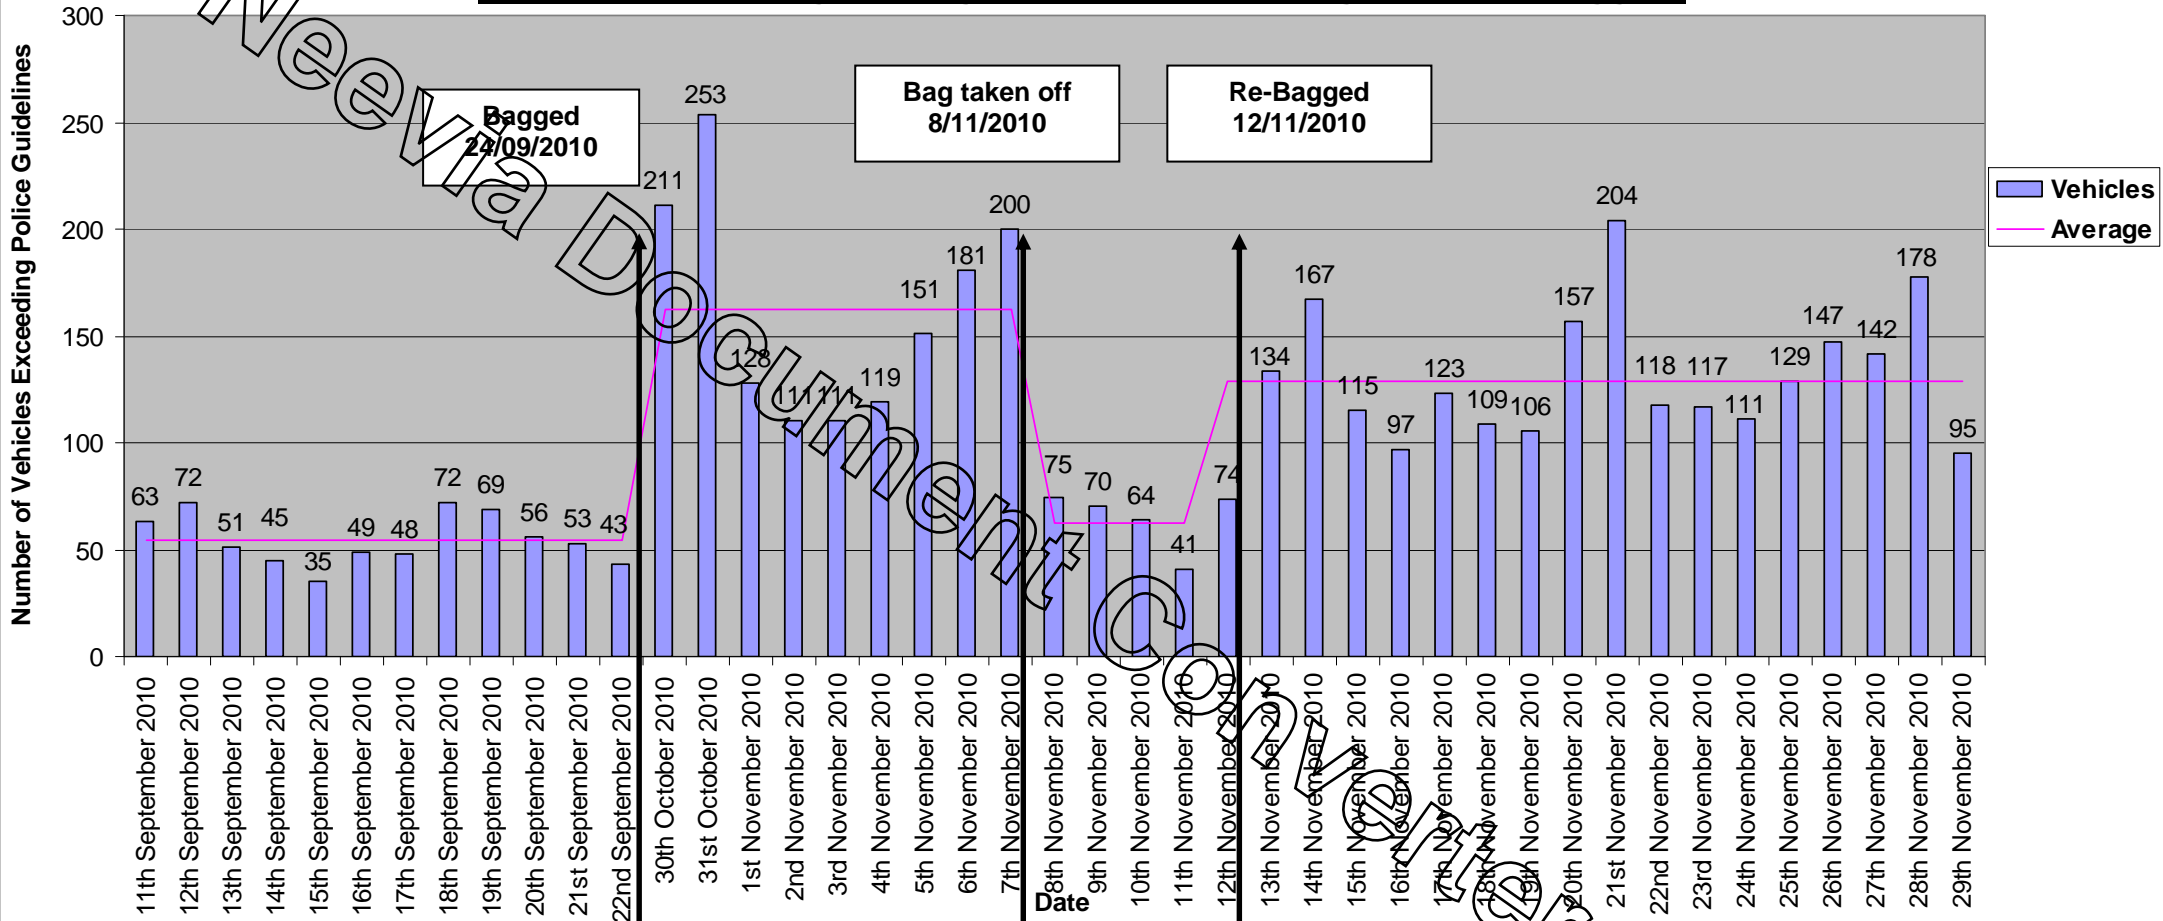
Bagged safety camera housing trial - A5250 Burton Road, Northbound
(Vehicles exceeding police guidelines prior, during, and post bagged)

Average: 55	Average: 163	Average: 63	Average: 129
<u>Camera Not Bagged</u>	<u>Camera Bagged SID in use</u>	<u>Camera Not Bagged</u>	<u>Camera Bagged SID Bagged</u>

The average number of vehicles each day exceeding police guidelines prior to the camera housing being bagged was 55. Once the camera housing was bagged, the average number of vehicles exceeding police guidelines increased to 163 vehicles per day. Once the bag was removed from the camera housing, the average number of vehicles per day decreased to 63. The camera housing was then re-bagged four days later which showed the average number of vehicles exceeding police guidelines increase to 129 vehicles per day.

Prior to the trial: 55 (*typically 0.54% of total traffic flow*)
while housing bagged with SID in use: 163 (*typical 1.94% of total traffic flow*)
with housing and SID bagged: 129 (*typically 1.4% of total traffic flow*)

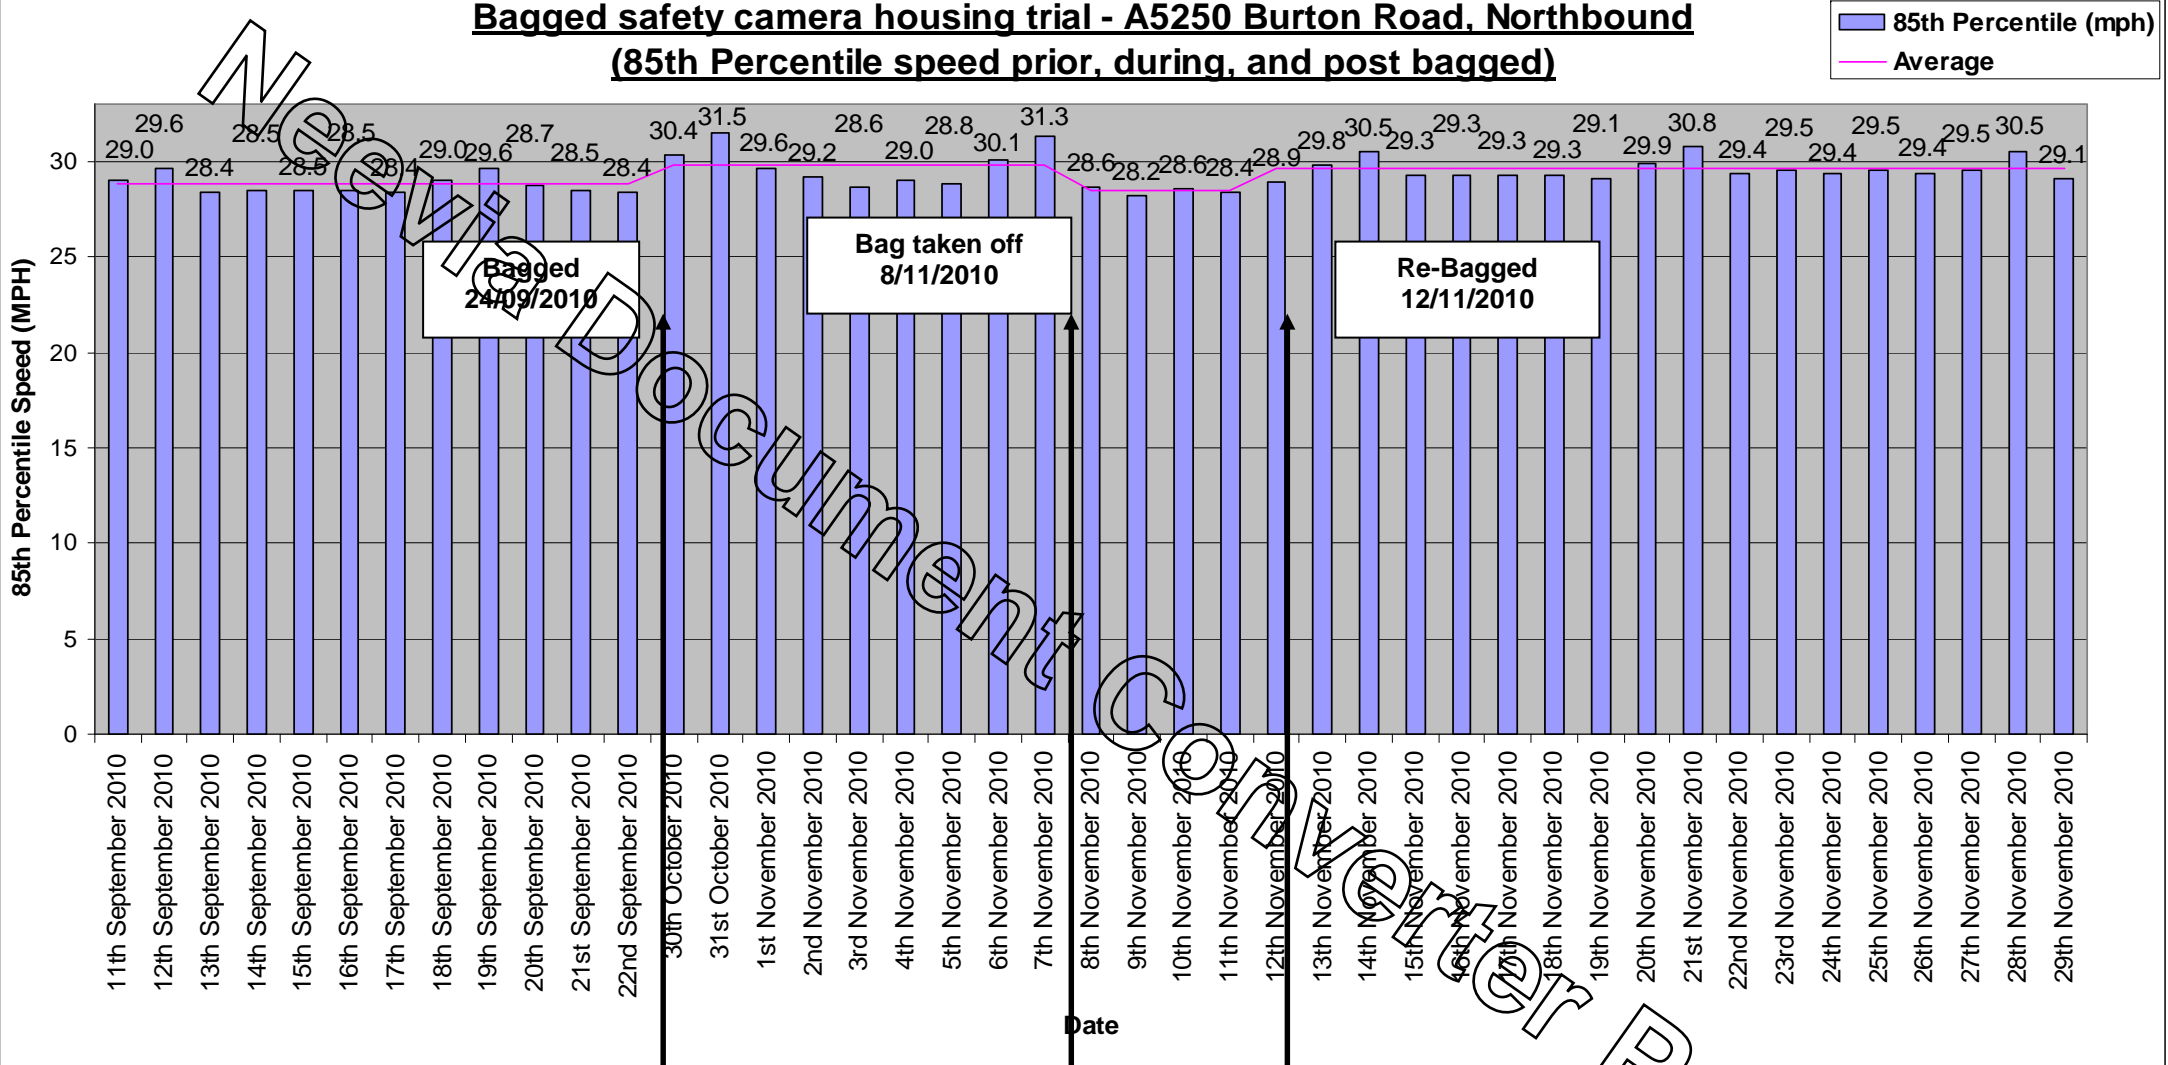
Bagged safety camera housing trial - A5250 Burton Road, Northbound (85th Percentile speed prior, during, and post bagged)

Average: 28.8 mph	Average: 29.6 mph	Average: 28.5 mph	Average: 29.6 mph
<u>Camera Not Bagged</u>	<u>Camera Bagged</u> <u>SID in use</u>	<u>Camera Not</u> <u>Bagged</u>	<u>Camera Bagged</u> <u>SID Bagged</u>

The average 85th percentile speed before the camera housing was bagged was 28.8 mph. Once the camera housing was bagged, the average 85th percentile speed increased to 29.8 mph. Once the bag was removed from the camera housing, the average 85th percentile speed decreased to 28.5 mph. The camera housing was then re-bagged four days later which showed the average 85th percentile speed increase to 29.6 mph.

Average 85%ile speeds prior to trial starting: 28.8mph
Average 85%ile speeds while housing bagged with SID in use: 28.5mph
Average 85%ile speeds with housing and SID bagged: 29.6mph

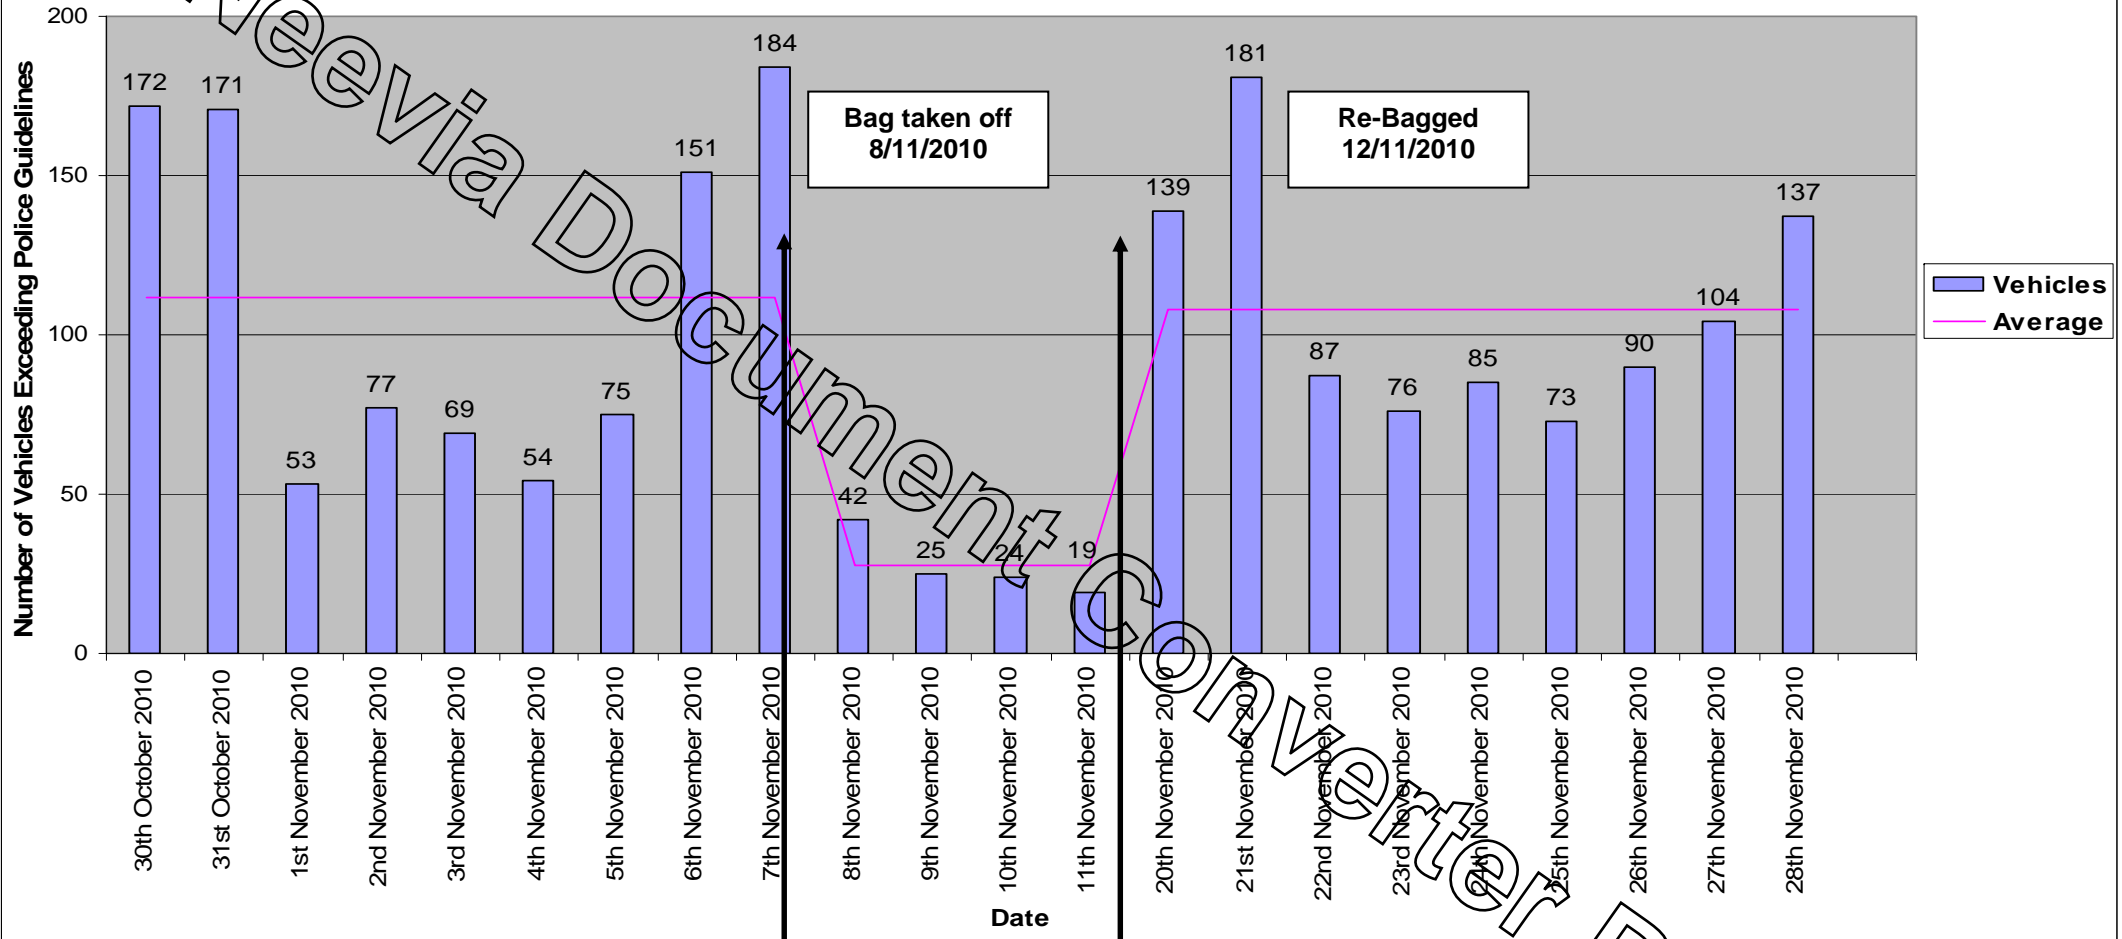
Bagged safety camera housing trial - A6005 Nottingham Road, Eastbound
(Vehicles exceeding police guidelines prior, during, and post bagged)

Average: 112	Average: 28	Average: 108
<u>Camera Bagged</u> <u>SID in use</u>	<u>Camera Not Bagged</u>	<u>Camera Bagged</u> <u>SID Bagged</u>

The average number of vehicles each day exceeding ACPO guidelines whilst the camera housing was bagged was 112. Once the bag was removed from the camera housing, the average number of vehicles per day decreased to 28. The camera housing was then re-bagged four days later which showed the average number of vehicles exceeding ACPO increase to 108 vehicles per day.

Prior to the trial: data not available
while housing bagged with SID in use: 112 (*typical 1.49% of total traffic flow*)
with housing and SID bagged: 108 (*typically 1.21% of total traffic flow*)

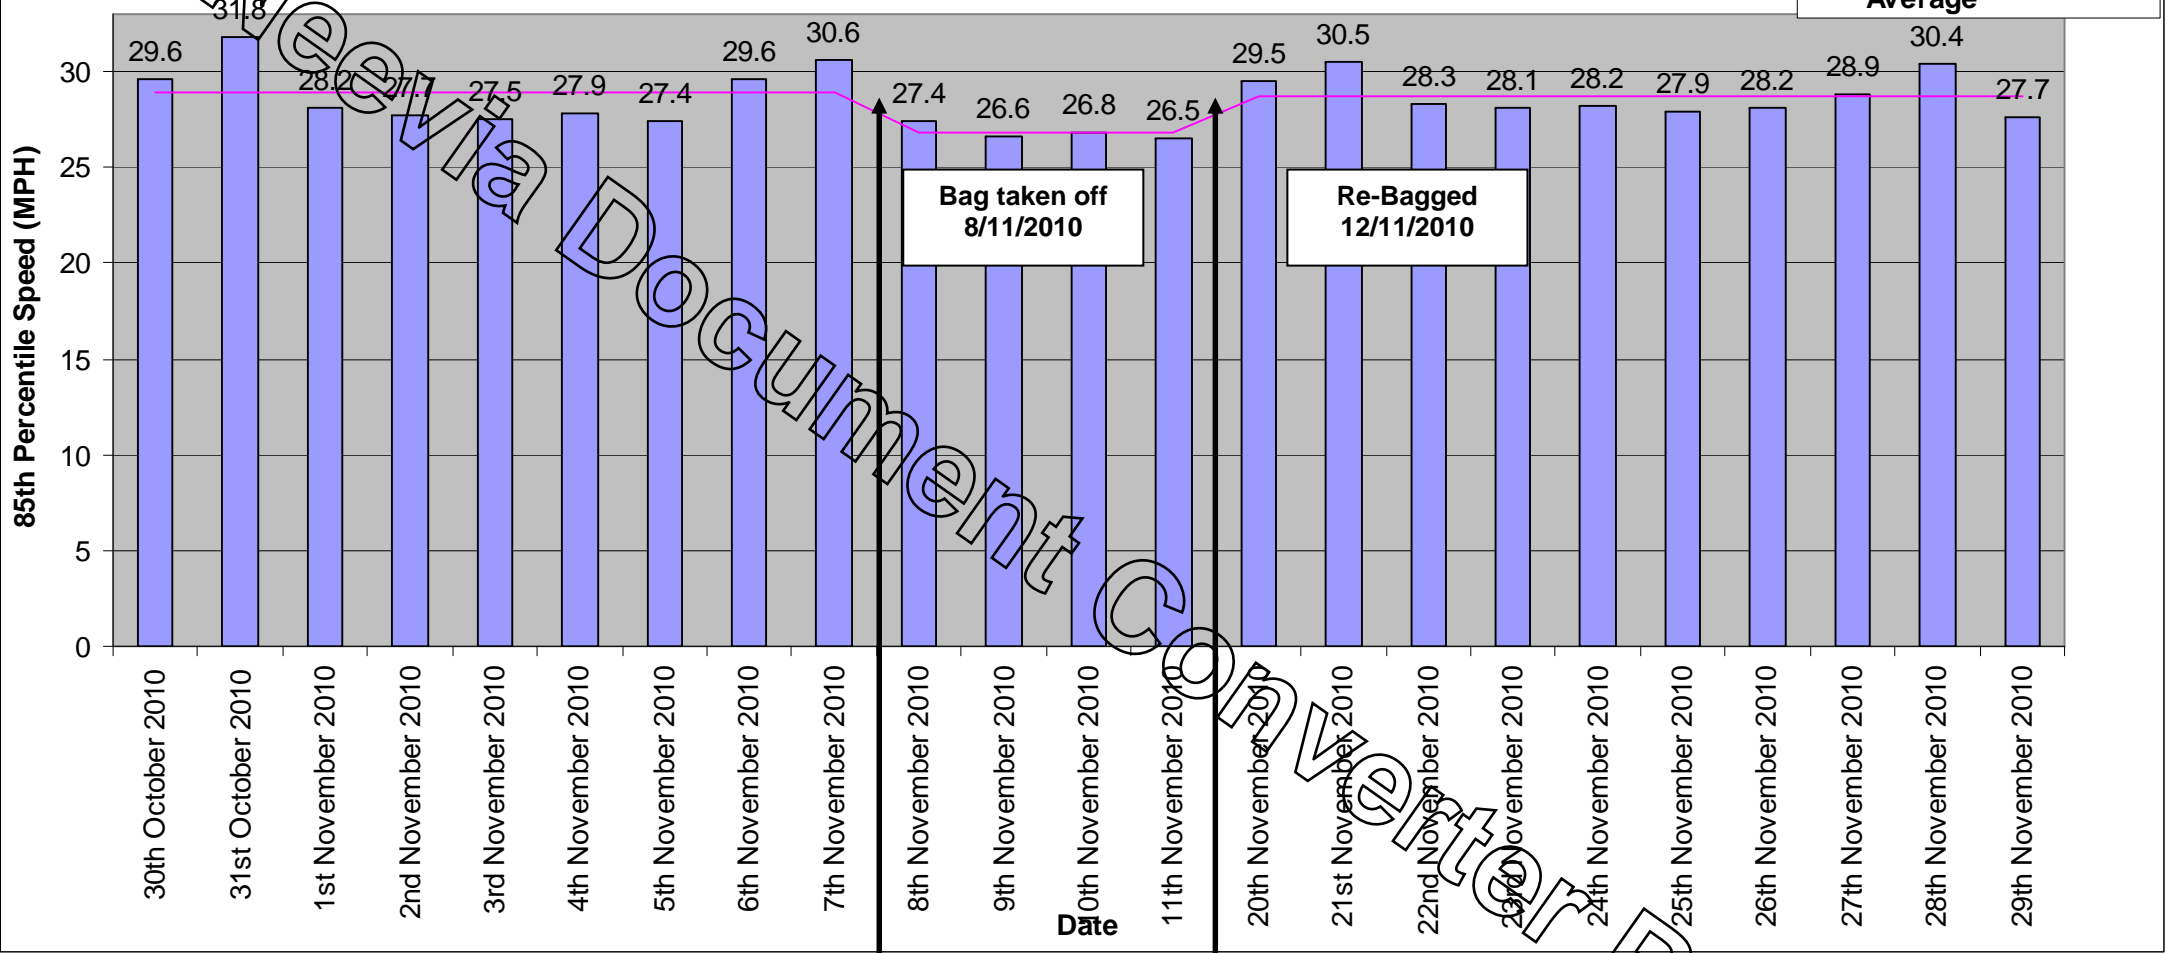
Bagged safety camera housing trial - A6005 Nottingham Road, Eastbound
(85th Percentile speed prior, during, and post bagged)

Average: 28.9 mph	Average: 26.8 mph	Average: 28.7 mph
<u>Camera Bagged</u> <u>SID in use</u>	<u>Camera Not Bagged</u>	<u>Camera Bagged</u> <u>SID Bagged</u>

The average 85th percentile speed whilst the camera housing was bagged was 28.9 mph. Once the bag was removed from the camera housing, the average 85th percentile speed decreased to 26.8 mph. The camera housing was then re-bagged four days later which showed the average 85th percentile speed increase to 28.7 mph.

Average 85%ile speeds prior to trial starting: no data available
Average 85%ile speeds while housing bagged with SID in use: 28.9mph
Average 85%ile speeds with housing and SID bagged: 28.7mph

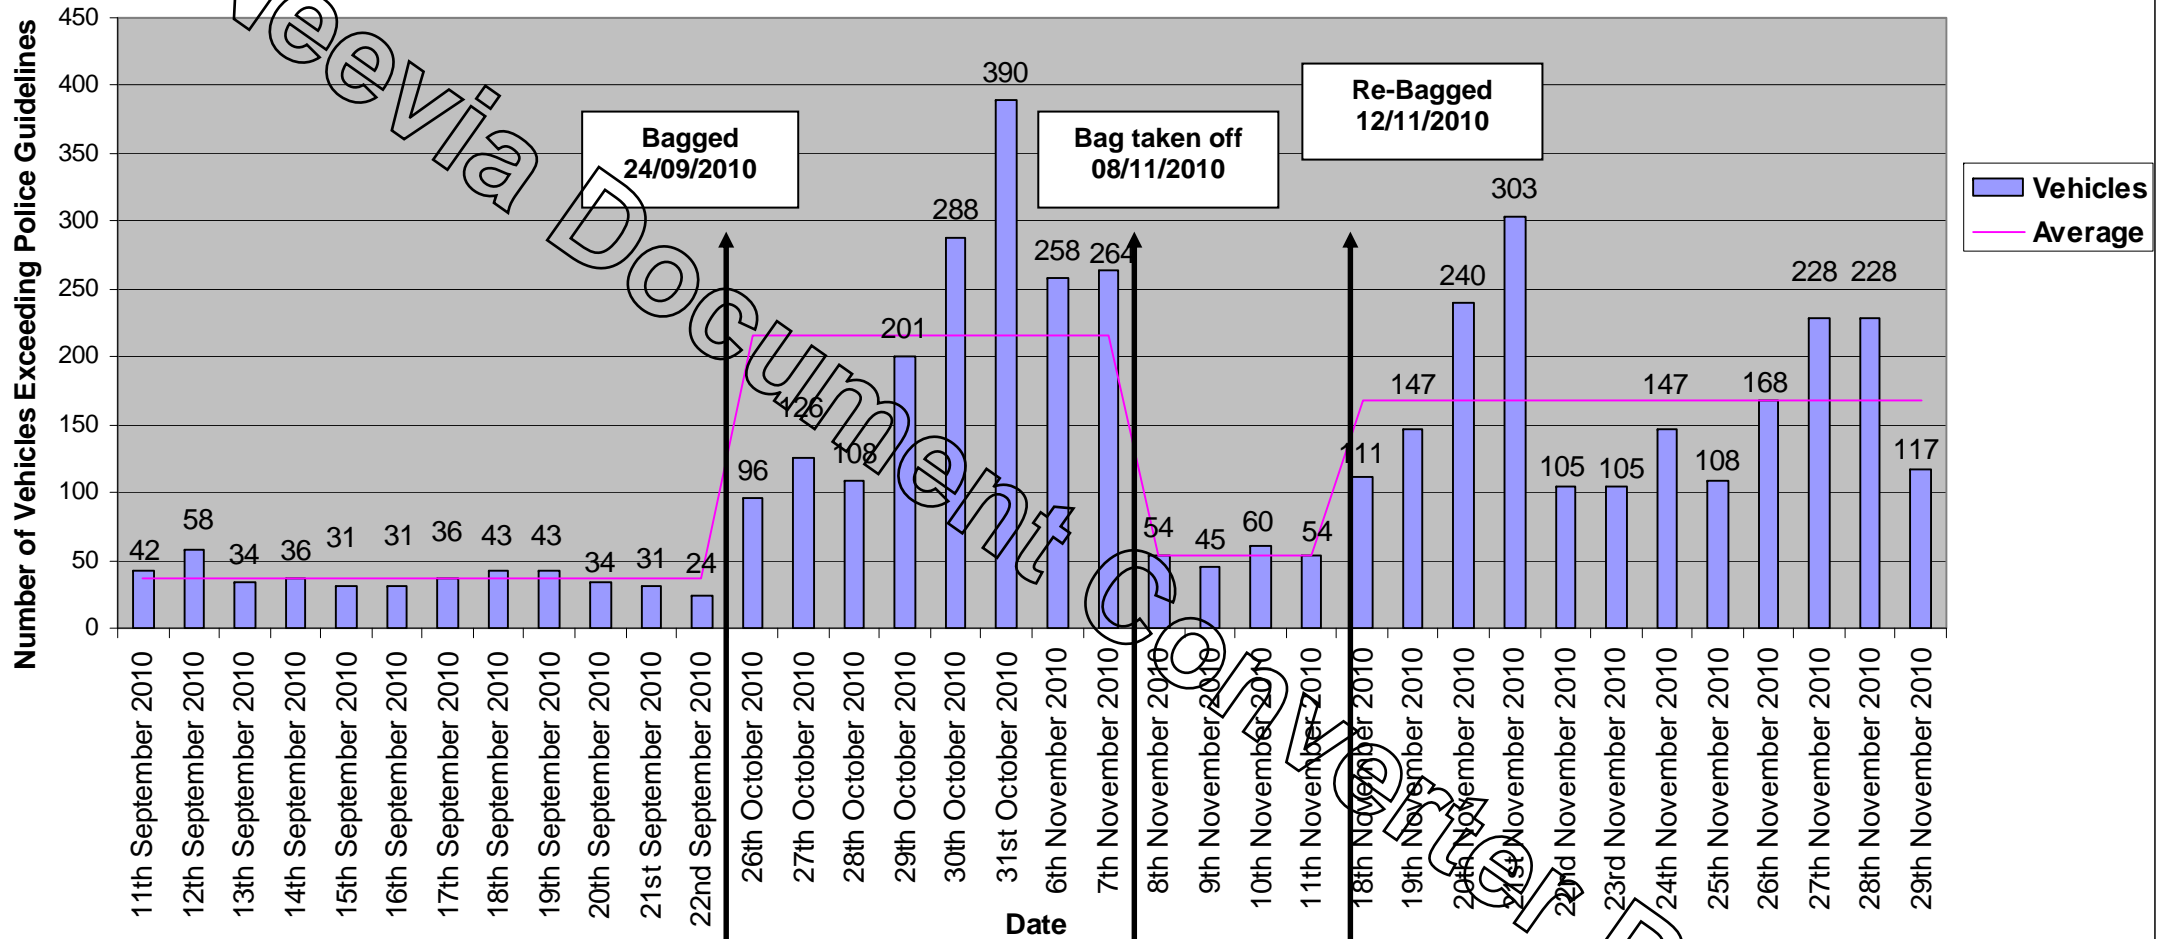
Bagged safety camera housing trial - A514 Shelton Lock, Northbound (Vehicles exceeding police guidelines prior, during, and post bagged)

Average: 37	Average: 216	Average: 53	Average: 167
<u>Camera Not Bagged</u>	<u>Camera Bagged</u> <u>SID in use</u>	<u>Camera Not</u> <u>Bagged</u>	<u>Camera Bagged</u> <u>SID Bagged</u>

The average number of vehicles each day exceeding police guidelines prior to the camera housing being bagged was 37. Once the camera housing was bagged, the average number of vehicles exceeding police guidelines increased to 216 vehicles per day. Once the bag was removed from the camera housing, the average number of vehicles per day decreased to 53. The camera housing was then re-bagged four days later which showed the average number of vehicles exceeding police guidelines increase to 167 vehicles per day.

Prior to the trial: 37 (*typically 0.3% of total traffic flow*)
while housing bagged with SID in use: 216 (*typical 2.53% of total traffic flow*)
with housing and SID bagged: 167 (*typically 1.72% of total traffic flow*)

Again, there was little change in speeds during the trial. However, there was a 486% increase in vehicles exceeding the speed enforcement threshold once the housing was covered. Compliance prior to the trial was extremely high, with only 0.3% of vehicles exceeding the threshold in a typical day. This rose to 2.53% once the housing was covered.

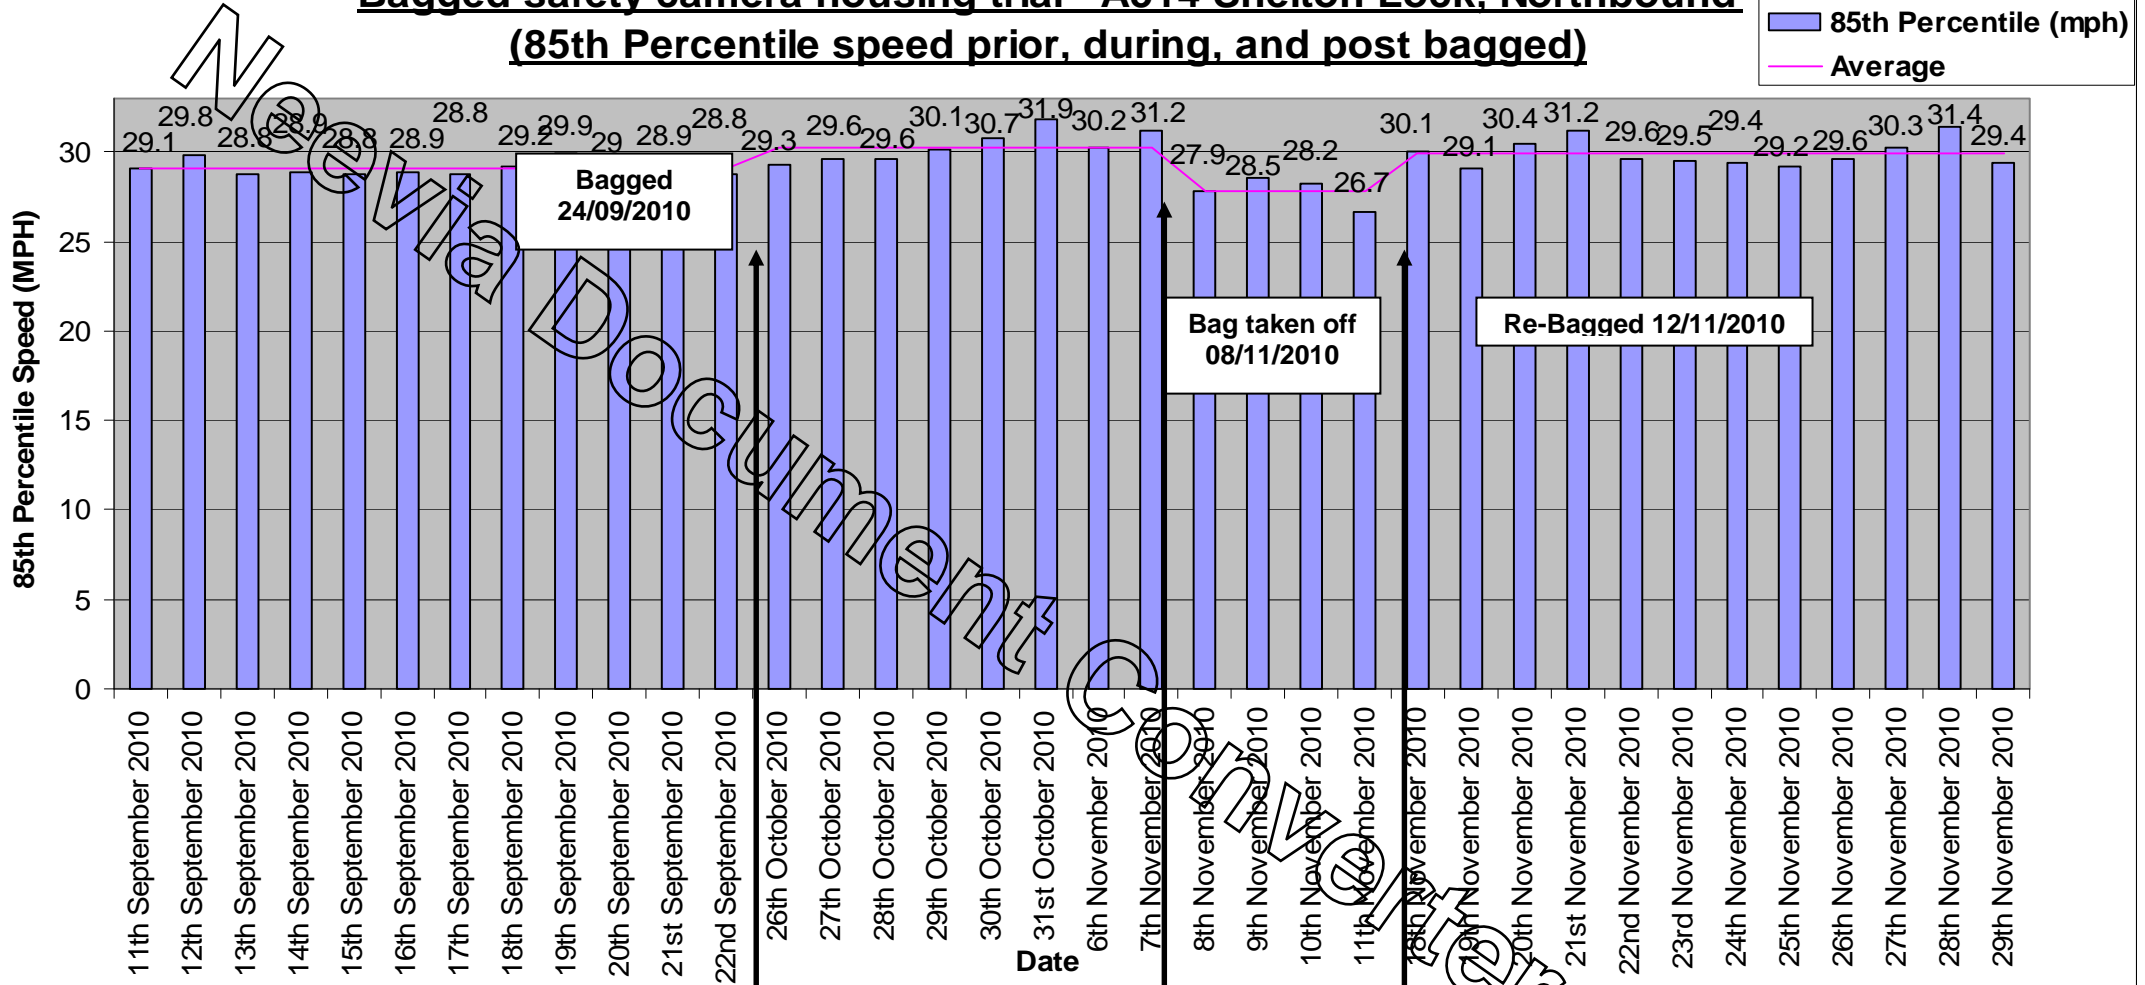
Bagged safety camera housing trial - A514 Shelton Lock, Northbound (85th Percentile speed prior, during, and post bagged)

Average: 29.1mph	Average: 30.3 mph	Average: 27.8 mph	Average: 29.9 mph
<u>Camera Not Bagged</u>	<u>Camera Bagged SID in use</u>	<u>Camera Not Bagged</u>	<u>Camera Bagged SID Bagged</u>

The average 85th percentile speed before the camera housing was bagged was 29.1 mph. Once the camera housing was bagged, the average 85th percentile speed increased to 30.3 mph. Once the bag was removed from the camera housing, the average 85th percentile speed decreased to 27.8 mph. The camera housing was then re-bagged four days later which showed the average 85th percentile speed increase to 29.9 mph.

Average 85%ile speeds prior to trial starting: 29.1mph
Average 85%ile speeds while housing bagged with SID in use: 30.3mph
Average 85%ile speeds with housing and SID bagged: 29.9mph
