# Investigation Report into November 2019 Derwent Floods in Derby City

Derby City Council

Project number: 60675186

15th September 2022

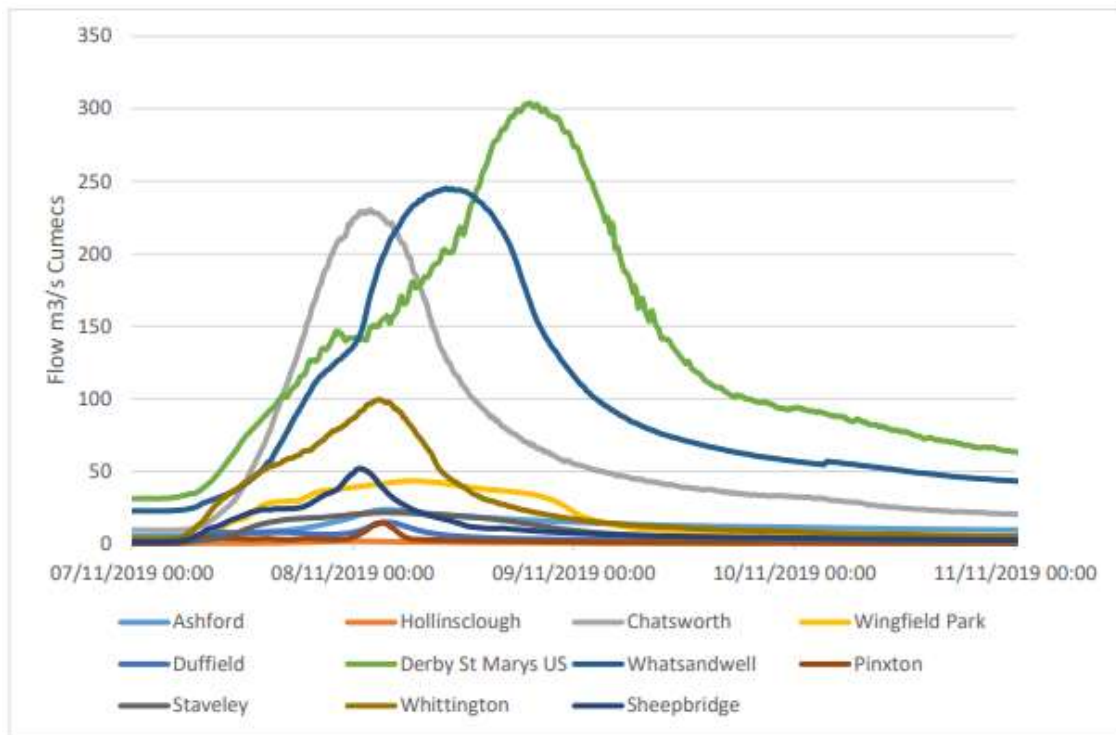
**Figure 5-7: River Flows across Derbyshire 7<sup>th</sup> to 11<sup>th</sup> November 2019<sup>4</sup>.**

The river peak flow response can be seen propagating downstream from the headwaters of the River Derwent, from Chatsworth towards Derby St Mary's (Figure 5-7). On 8<sup>th</sup> November 2019 the River Derwent at St Mary's Bridge (28085) gauging<sup>7</sup> station recorded a peak flow of 304 cubic meters per second 19:15 (Figure 5-7), which is the highest peak recorded at this station since gauging started in 1985.

On 6th – 7th November heavy rainfall (100-125mm rain radar totals) in the headwaters of the River Derwent, and an observed total rainfall of 83.6mm (over 20 hours on 8<sup>th</sup> Nov) with a return period of 25 years at Derwent Reservoir, fell on saturated ground causing runoff into the River Derwent, leading to the river response observed propagating downstream to Derby on the 8th November (Figure 5-7).

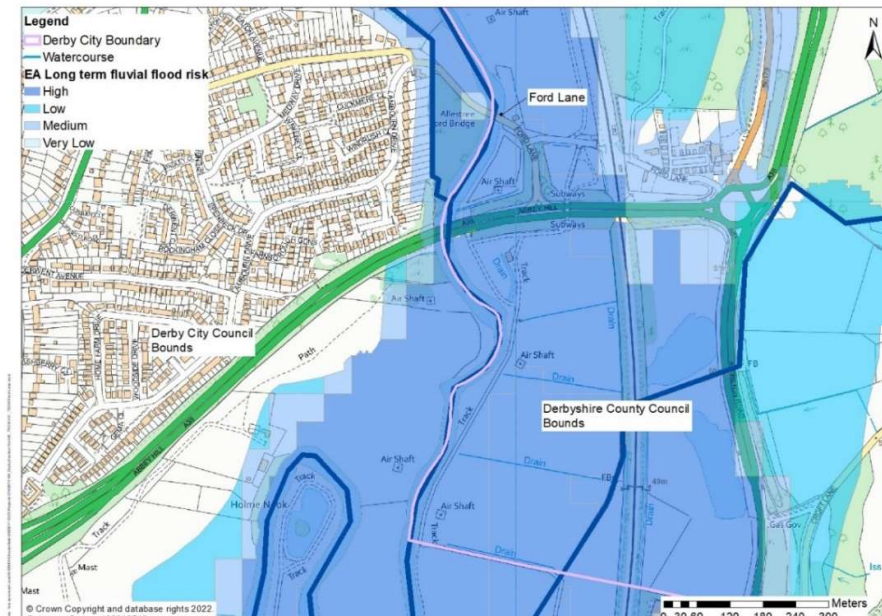
**Figure 5-9: Ford Lane Fluvial Flood Risk Map**

During the flood event one residential property on Ford Lane was reported as being flooded internally over most of the ground floor, which required the resident to be rescued through an upstairs window. Additionally, as a result of the flooding the train track at this point was closed and trains were required to reverse back to Derby Station. To the east of the railway tracks several caravans were reported as flooded in a caravan park. The flooding is understood to be caused by high water levels in the River Derwent resulting in the river overtopping its banks. This is an area which is known to have a high risk of fluvial flooding see Figure 5–9.

The area in which flooding was experienced on Ford Lane is within the Derbyshire County Council boundary (see Figure 5-9), however, due to its proximity with Derby, DCiC managed and undertook the response to the flooding in this area.

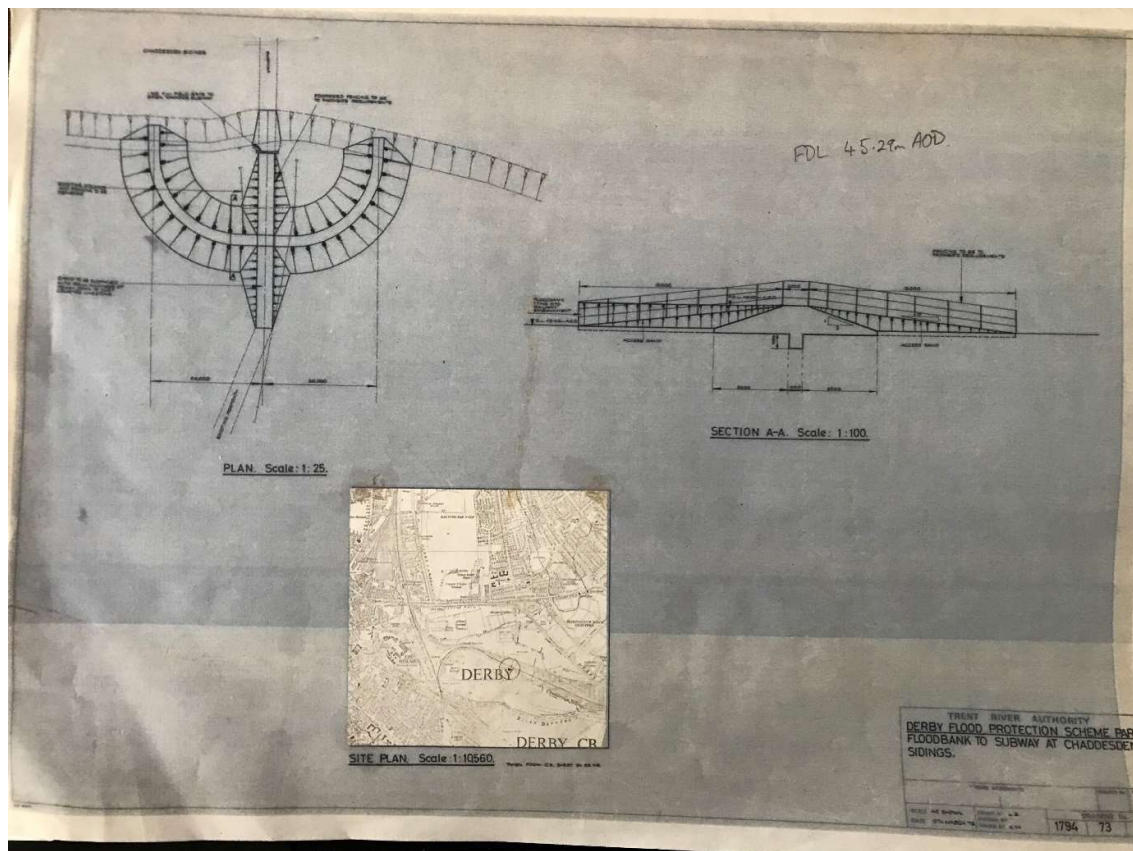
Figure 5-34: Historical drawings of Underpass Flood Defence Bund

During the flood event, flooding occurred across the flood plain, with the River Derwent overtopping its banks and flooding the area to the south of the railway tracks. Although the railway lines act as a flood embankment, preventing water from flowing further north, there is an underpass which allowed flood water to flow into Chaddesden Sidings, see Figure 5-33. A flood defence bund was previously constructed to maintain the defences and protect the underpass from fluvial flooding, see Figure 5-34. The EA are in charge of maintaining the flood defence bund. However, prior to the November 2019 event the bund was either removed or eroded, leaving a gap within the flood defences. This allowed flooding from the flood plain into Chaddesden Sidings.

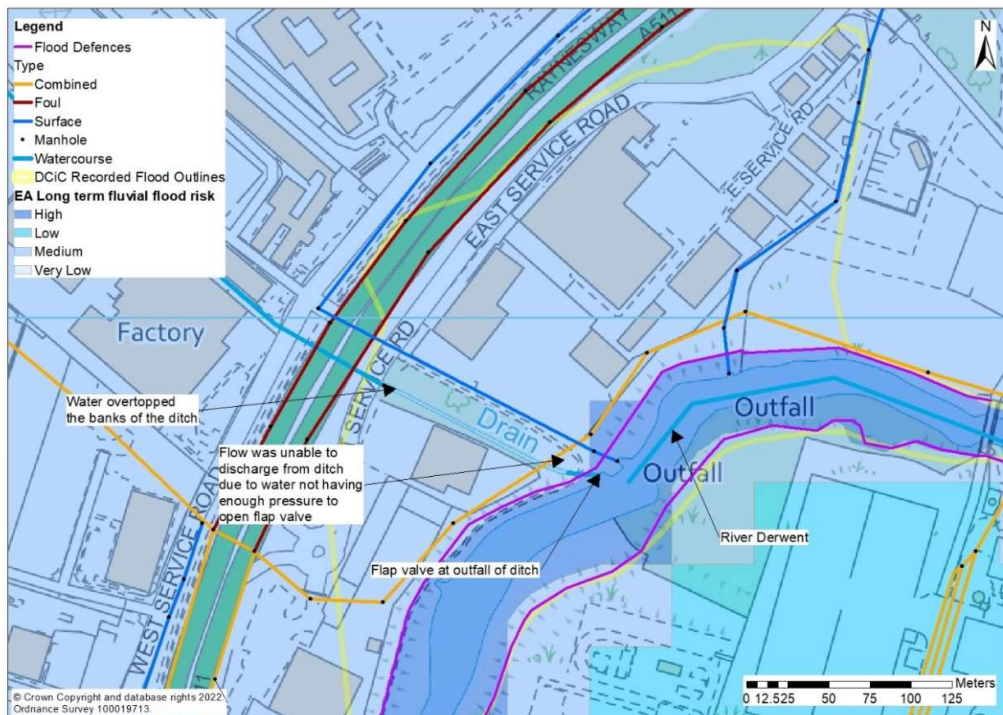
**Figure 5-36: November 2019 Recorded flood outlines at Raynesway (fluvial flood risk)**

Flooding on Raynesway occurred in two areas through different mechanisms. There was flooding within a commercial property's car park which is located next to a drainage ditch, see Figure 5-36. The ditch outfalls into the River Derwent using an outfall equipped with a flap valve. Due to high river levels in the River Derwent, the water within the ditch during the flood event did not have enough pressure to open the flap valve and was not able to discharge. This resulted in the ditch filling and overtopping its banks, flooding into the adjacent car park up to an approximate maximum depth of 300mm, see Figure 5-38. This is an area identified as having a high risk of fluvial flooding from the EA's fluvial flood map, as can be seen in Figure 5-36.
