Sinfin Central Business Park, Sinfin Lane, Derby - TPO 2005 no. 441

Introduction

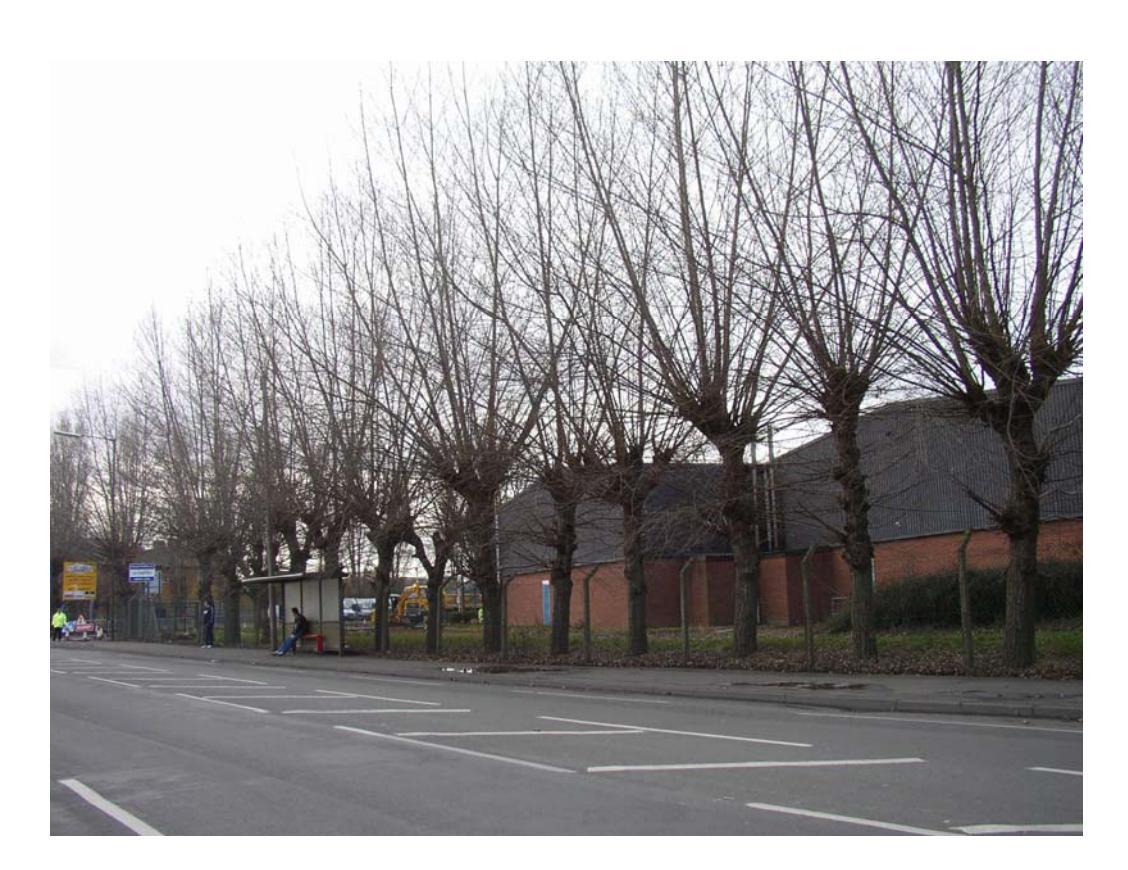
Consist of a row of black poplars that have been pollarded (cut back to the main stem on a regular basis). They are very in keeping with the area, Sinfin being generally wet and marshy and poplars growing well in this type of environment.

Group G1 (G2 beyond access road, trees similar in size and condition)

The defects noted in the report would not be a significant issue if the trees were pollarded on a regular basis. This can be covered by the submission of an application.

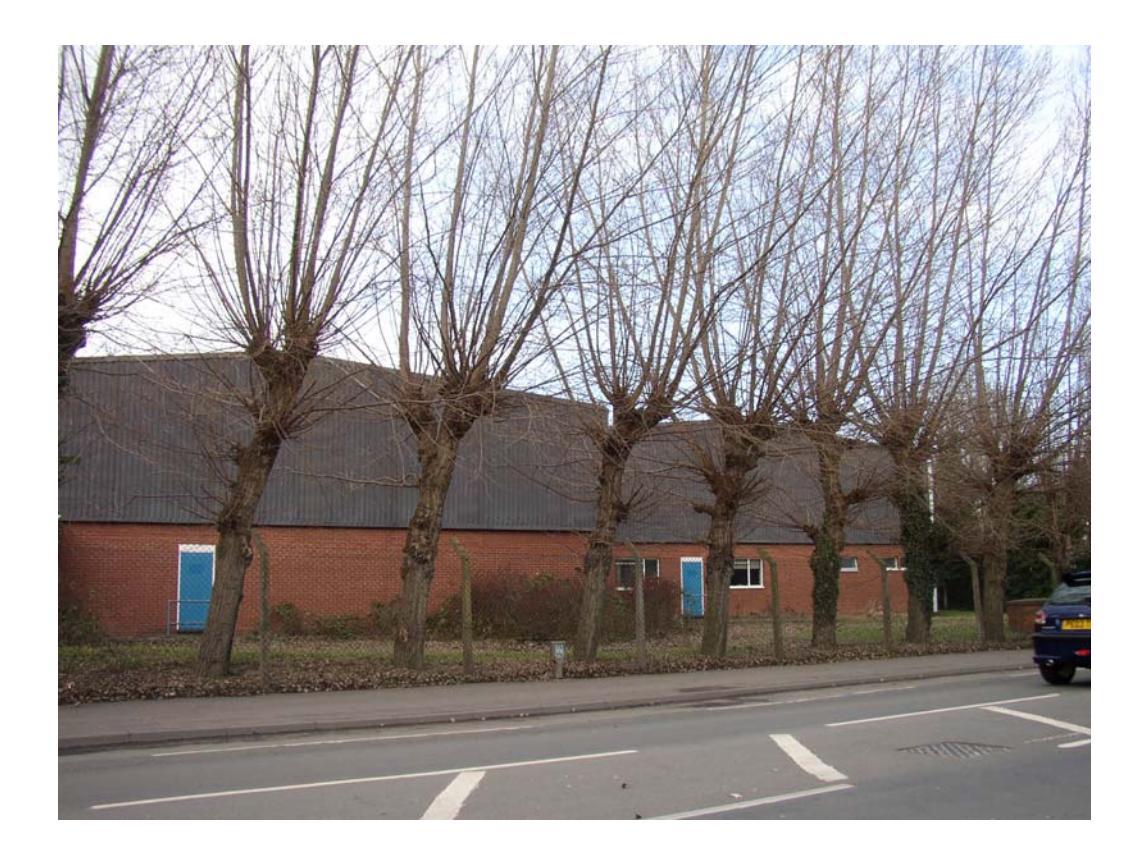
Group G1

The fact that the trees have been pollarded does not detract from their amenity value as this is a traditional management technique for trees of this species.
